# Post incident inspection following unsafe occurrences at Lavistown Level crossing. 29-31 March 2012

Issue	Prepared by	Checked by	Issue date
First draft	AJH	AB	19/05/12
Draft for Comment	AJH	AB	28/06/12
Finalised	AJH	AB	28/08/12

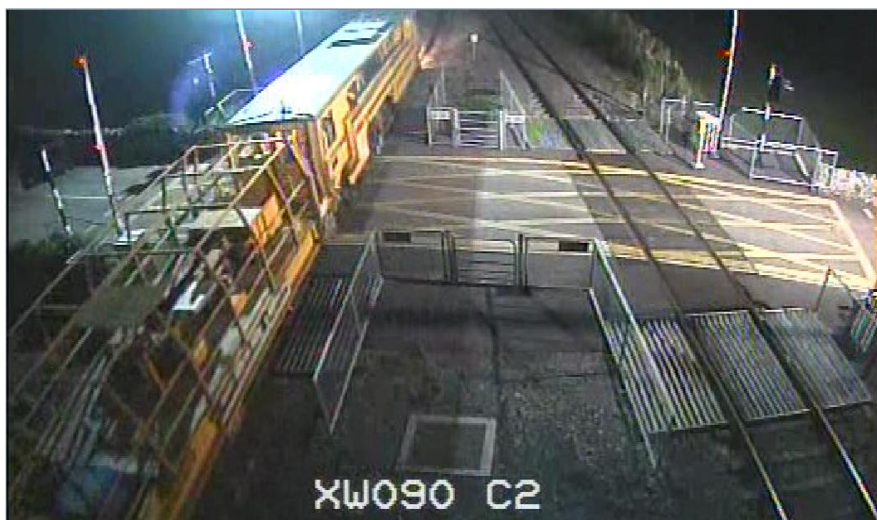
4.3.1-1 Image from CCTV at XW 090

- At 00:59 (00:55) Y741 can be observed passing through XW 090 (Shown in Figure 4.3.1-1). The presence of IÉ staff at the crossing cannot be seen in this footage.

- 00:59 Level crossing control centre operator contacts CTC signaller and states that the machine has gone through with the gates in the air.
- 01:00 Signalman contacts driver. First the driver is instructed to bring their machine to a stop, then the following conversation took place:

**06/12-PII-AR 3:** IEÉ to review the instructions for the control of CCTV level crossings in possessions  
IEÉ should review the instructions given to staff to control CCTV level crossings in possessions and degraded working conditions. Particular focus should be given to standardising the interface between signallers, Crossing Controllers and possession staff.  
**PCD:** 12 months from final issue of report
