Preliminary Post Incident Inspection

Incident: 140307 - Rushbrooke rock fall
176mp 100 yards

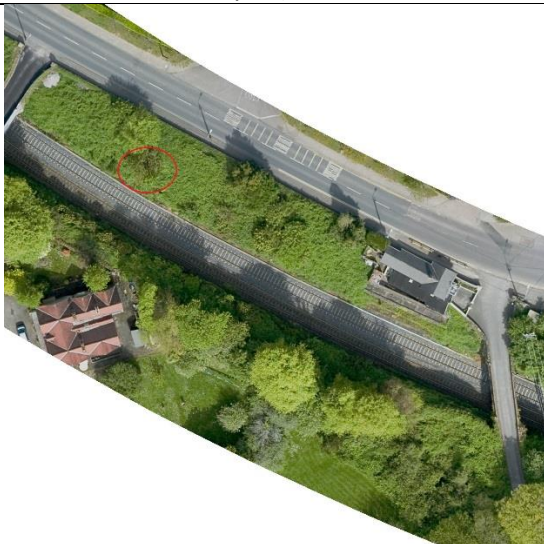
Figure 3 – Plan of incident location (Lidar)

The incident happened 500 yards south of Rushbrooke station at 176miles and 100 yards on the Cork-Cobh Down line between overbridges OBC434 & OBC435. (See figures 1-4)

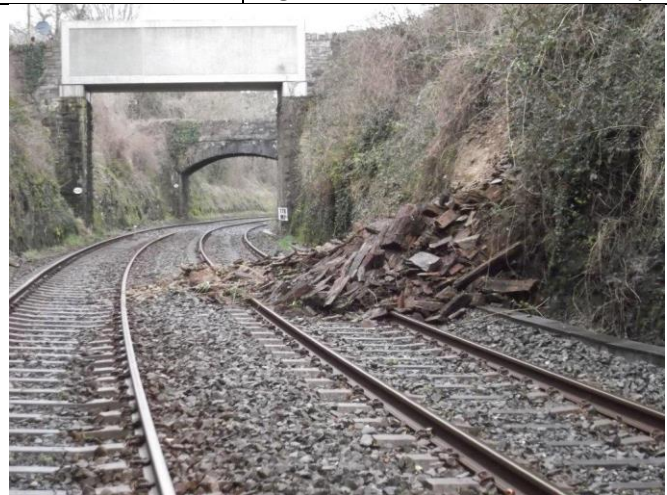
Figure 4 – Photograph of rockfall (photograph facing UP to Cork)

At 22:40 on the 7th March 2014, a rock fall occurred at 176miles and 100 yards on the Down line between Rushbrooke and Cobh Stations on the Cork to Cobh line. (Between OBC434 & OBC435) The rockfall fouled both rails of the Down line (see figure 4).

It is not the purpose of this report to ascertain the cause of the incident but to check if Iarnród Éireann-Infrastructure and specifically the CCE department complied with their SMS. However, from the evidence supplied to the RSC, it is reasonable to assume that the rockfall was caused by the saturation of the cutting in the months prior to the incident given the rainfall levels were well above average compared to previous years. This increased saturation of the cutting and of the soil overburden coupled with the rock in the cutting being of a highly fractured mudstone/sandstone nature make this the most likely cause of the rockfall occurring.

39/14-PII-AR 1: Structural assessment and drainage study of the cutting between Rushbrooke and Cobh

An assessment of the structural integrity of the cutting and carry out a drainage survey of the area and subsequently where deemed necessary carry out a programme of physical works to ensure that the risk of landslip/rockfall in the cutting is tolerable.

The CCE have carried out works in April 2014 that entailed the removal of weathered rock in a number of areas and further removal and tidying up of the rock at the slip site. A redundant section of retaining wall has been removed, felling of trees and removal of vegetation on the cutting tops. They have also carried out the removal and re-grading of soil material on cutting faces in a number of areas and de-vegetation in 1m strips to allow better inspection of the cutting.
