# Compliance inspection following a fatality at level crossing XM096, 2 September 2010

## Executive Summary

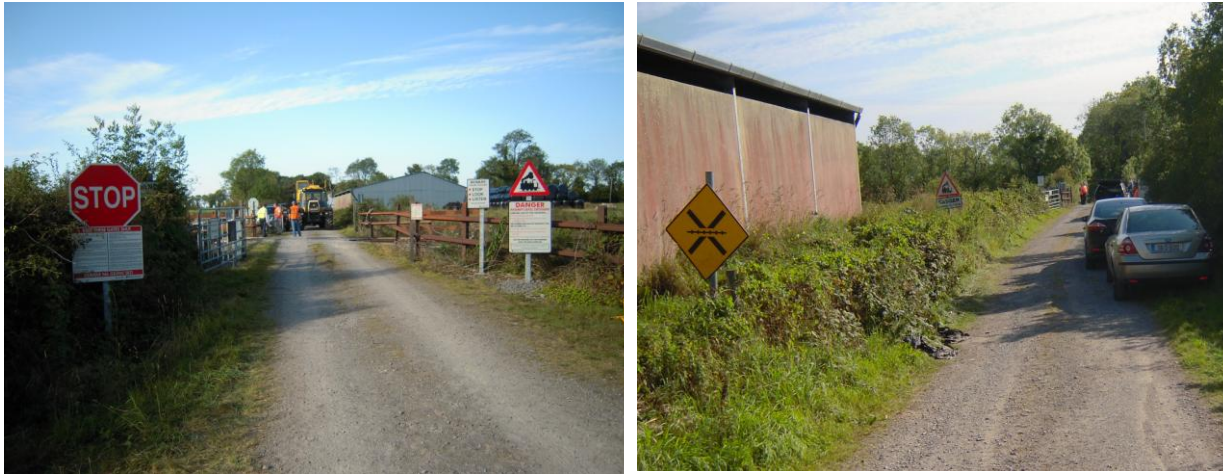
Figure 1: Signage at XM096 – South of railway line (left) and north (right) Photos taken -2<sup>nd</sup> September 2010)

It was noted that the advance warning sign on the road to the north of the railway (above right) incorrectly indicated the presence of an open crossing rather than a gated crossing. However, as the tractor was driven from the south, this was not a factor in the accident. IÉ were aware of this anomaly and correspondence was seen by the RSC confirming IÉ had advised the appropriate authority for road signage in the area (Roscommon County Council).

<b>RSC1</b>	<b>Advise local authorities of their duties regarding level crossing signage on approaches</b> The RSC should notify Local Authorities of their duties and the requirements for warning signage as specified in the Traffic Signs Manual (2010). This could be supplemented by high-lighting the issue at the Road Rail Safety Working Group (RRSWG), chaired by the RSC.
Priority	High
Timescale	1 month

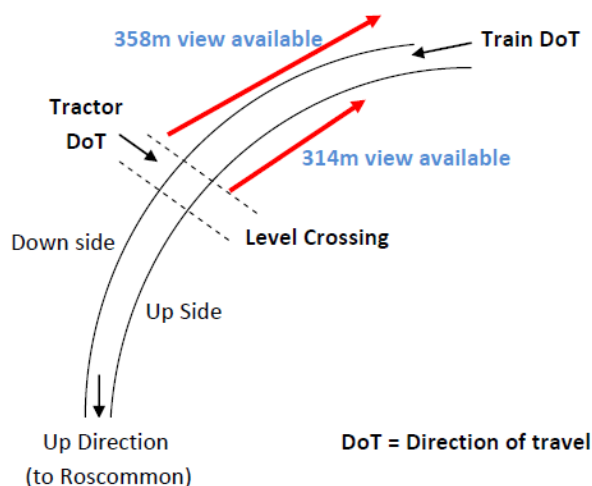
Figure 4: Site Layout with available views (measured 30th Sept 2010)

It is noted that the tractor travelled across the level crossing from the down side to up side and that the available sighting for such a movement met the requirements of the MW50 standard. Equally the RSC is mindful of the fact that the train involved in the collision was a freight train which had a permissible speed of 50 mph and this speed limit was observed.

The crossing was surveyed after the collision, on 30 September 2010, and the viewing distance in the down direction from the up side for the line was recorded as 314m. This is less than that required by Standard MW50 which, as previously stated, requires 350m for a train speed of 70 mph on single line track which is the speed limit for passenger services on this section of track.

<b>IEÉ1</b>	<p><b>Non-compliance with IEÉ Standard MW50 Section 2 : Views of approaching trains</b></p> <p>The minimum view necessary for XM096 to be perfectly safe with normal vigilance on the part of the user', taking the normal line speed (70 mph) into account was not met in accordance with the above standard.</p>
-------------	--
