A post incident inspection into the derailment of J608 at Wicklow -16th November 2009

Prepared by	Ian Lake
Version and Date	Final 22 nd Dec 2009

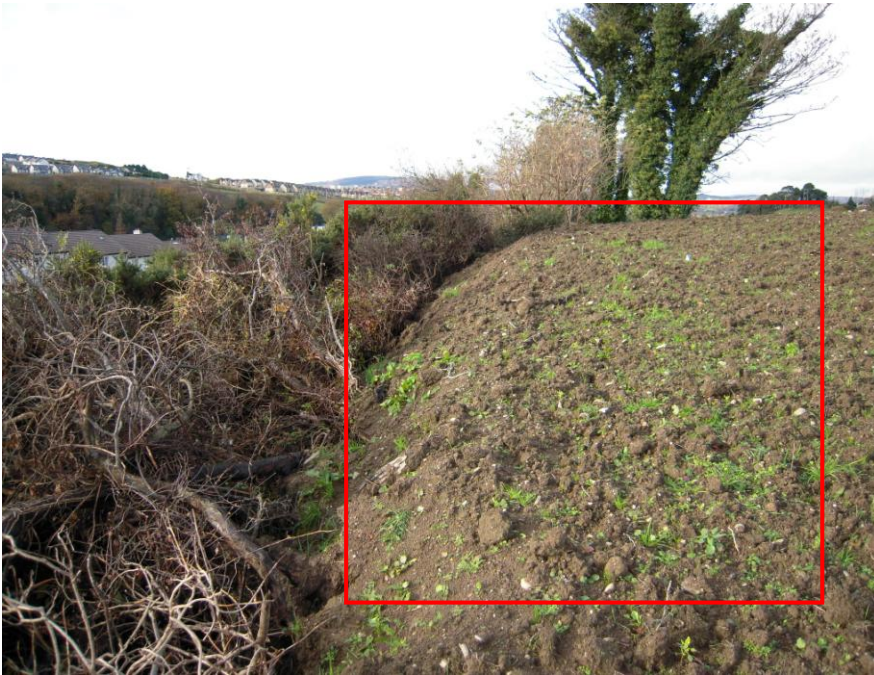
An inspection of the site above the top of the cutting indicated that ‘surcharging’ or building up of the level of the land had taken place at the top of the cutting beyond the boundary fence, where the land is in use as a field.

A preliminary report by a civil engineer specialising in earthworks and geo-technical matters (engaged by Irish rail) has identified surcharging to a depth of 1m. This included deposition into and over a field drain running parallel to the railway at the top of the cutting. This activity exactly matches one of the Permanent Way Institute (PWI) defined causes of deep seated cutting slips*.

Photograph of field showing 'surcharging' or deposited soil at cutting top.

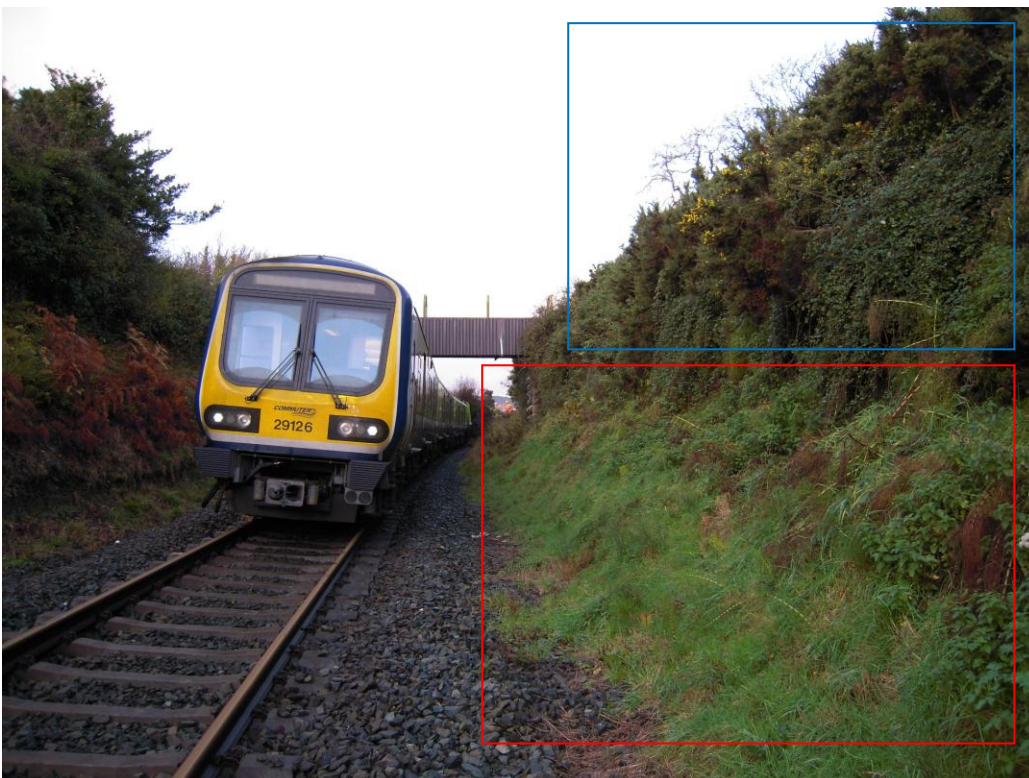
The cutting appeared to have unsubstantial vegetation consisting of brambles, bracken and long grass up to 3m above rail level. Above this height the vegetation appeared to be more substantial, consisting of gorse and trees. This profile appeared to be consistent with the use of a ‘flail’ unit – see the photograph in Appendix A.

Vegetation was partially trimmed in March 2008 by flail mower according to a statement from the Acting PWI. This accounts for the lower density foliage to below cant rail height.

The infrastructure inspection standards also make very limited reference to vegetation and no explanation on how this can present a problem. The level of vegetation would have undoubtedly made it difficult to observe any change in the upper part of the structure at Wicklow. It is also

possible that the presence of trees in the upper cutting side could have contributed to de-stabilising the steep slope.

Image illustrating the vegetation above the reach of the flail (blue) and in the reach of the flail (red).

1. To identify what the current status of the inspection of structures is, ascertain the extent of technical non-compliance with the relevant standard (I-STR-6510) and develop a plan with defined timescales to address any shortcomings.
2. To review the risk presented by vegetation on steep earthworks and particularly consider how this impacts upon their monitoring and inspection.
