Railway Safety Performance in Ireland

Commission for Railway Regulation

16/12/2016

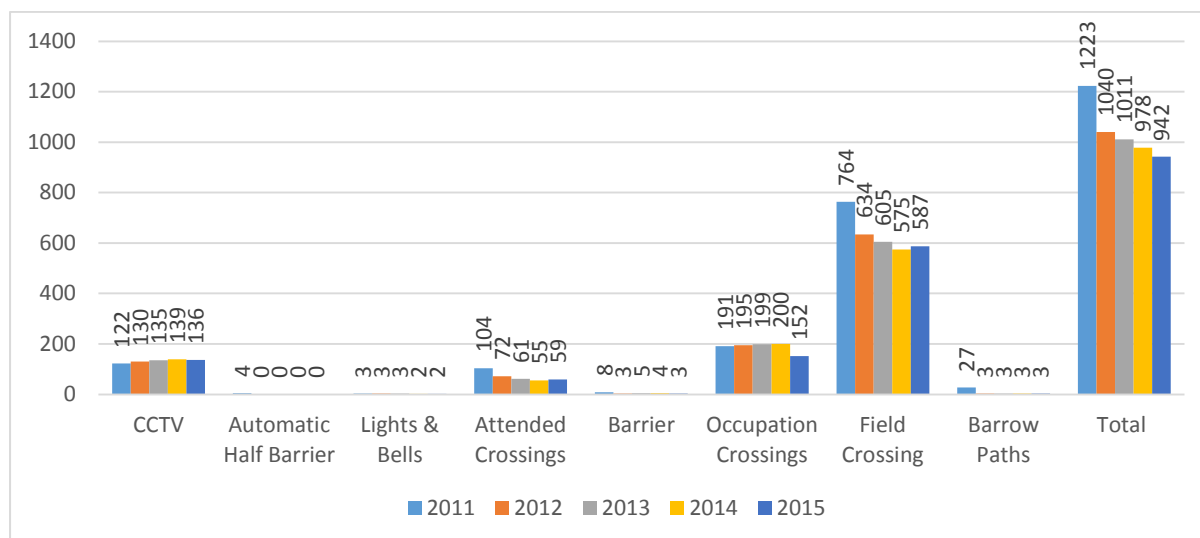
Figure 15 – Level Crossing by type in Ireland

The breakdown of level crossings by type and year in Ireland is shown in Figure 15. Level crossings on public roads that require the road user to manually open and close gates remain the highest risk type of level crossing, closely followed by 'Field type' level crossings. Recent years have seen a decline in investment for the removal or upgrade of level crossings. Iarnród Éireann are currently reviewing novel technological designs to enhance safety and operation at user-worked level crossings whilst operating within constrained budgets.

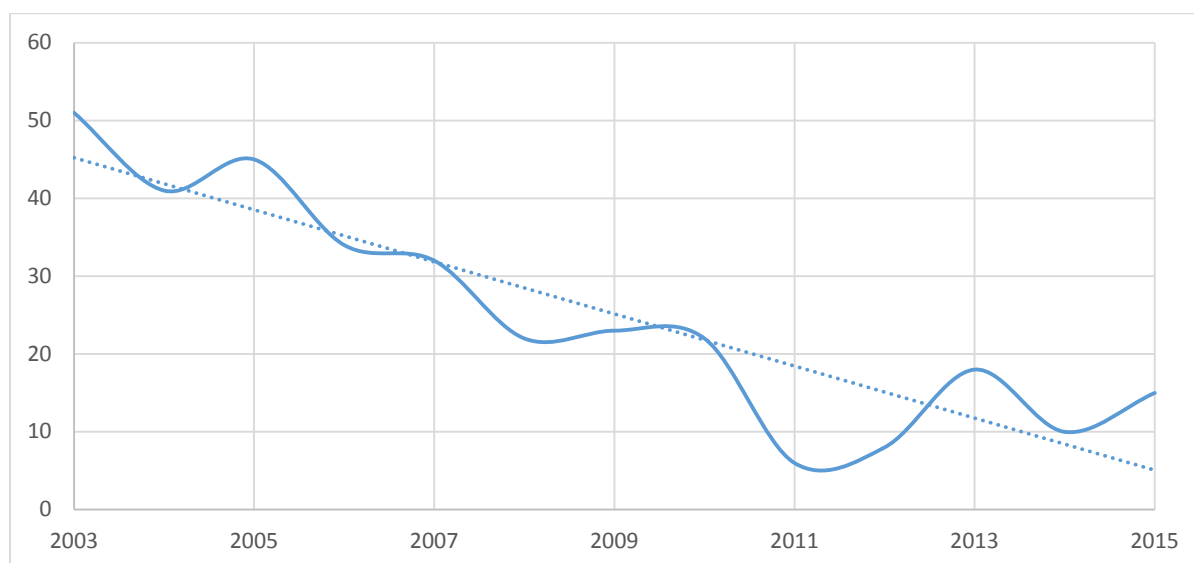
Figure 16 - IÉ SPADs by year

A SPAD is defined as having occurred when a train passes a stop (red) signal without authority. SPADs are a particular precursor event that the CRR monitors regularly during its supervisory meetings with IÉ. The trend in recent years has been a steady decline, but has started to rise again since the low of 2011.

IÉ use a ranking tool developed in Great Britain by an industry body to determine whether each SPAD had the potential to cause an accident. A significant amount of information relating to each SPAD is collated. Using this information, IÉ determine a weighted numeric score for each occurrence and the score dictates the level of internal investigation. SPADs are categorised by type and are grouped into one of 3 severity bands; Low Risk; Medium Risk; and High Risk.

The trend is being monitored as part of specific supervision activities by the CRR, as noted in the Commission's 2013 Annual Report, "there was a significant increase in SPAD events on the IÉ network during that year. Although there was a reduction in the number of incidents in 2014, nonetheless the total for that year was still higher than that experienced in each of the years 2011 and 2012. There was a further rise in the number of SPADs during 2015."

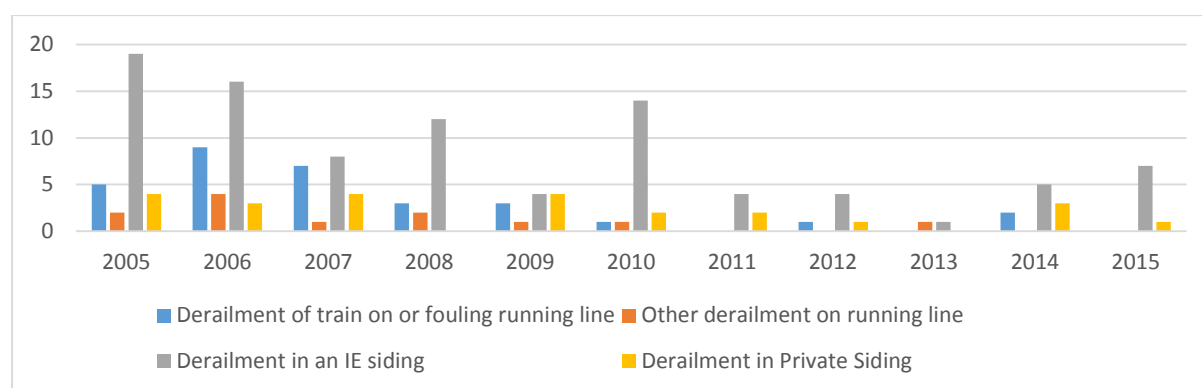
Figure 17 - Train Derailments by Year

Train derailments remain at low levels. Continued track and rolling stock maintenance, in conjunction with targeted renewals of track, should ensure that this type of incident rarely occurs.

Derailments in IÉ Sidings are observed to have continued to increase. IÉ has committed to auditing safety systems for train operations on sidings, and it is expected this will identify several improvements to current procedures.

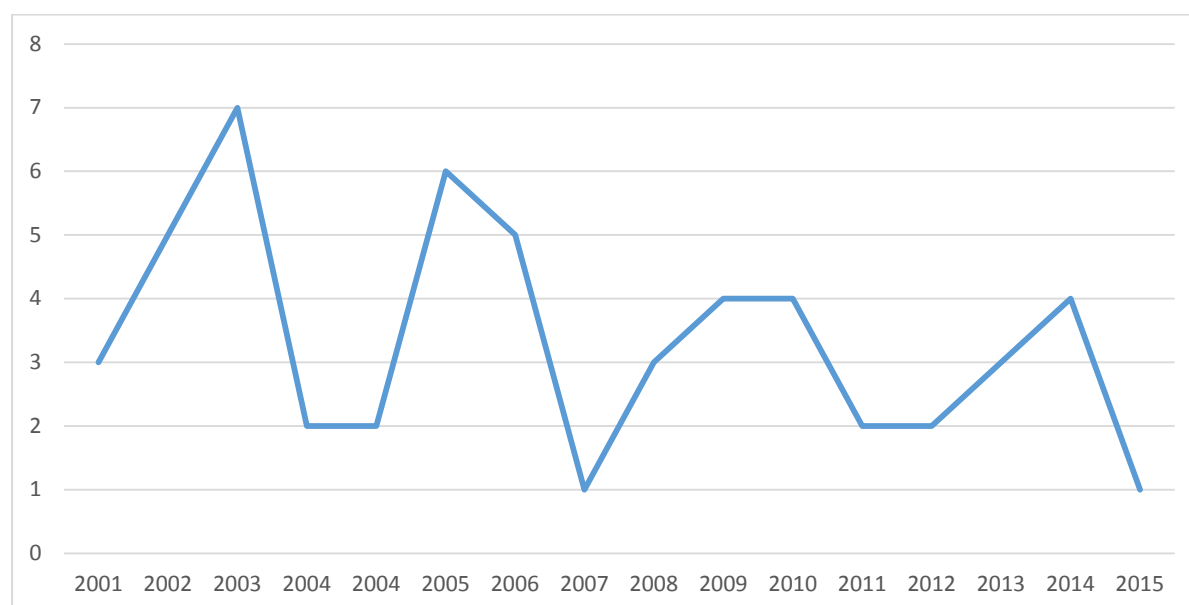
Figure 19 - Broken Rails by year

Iarnród Éireann visually inspects the track at least once per week and rails are ultrasonically tested at least every 2 years, with the vast majority tested annually. There was a single broken rail on a passenger carrying line in 2015. Whilst this did not result in a train accident, it is an area where IÉ remains vigilant. The CRR closely monitors Iarnród Éireann's management of its assets through regular supervision meetings.

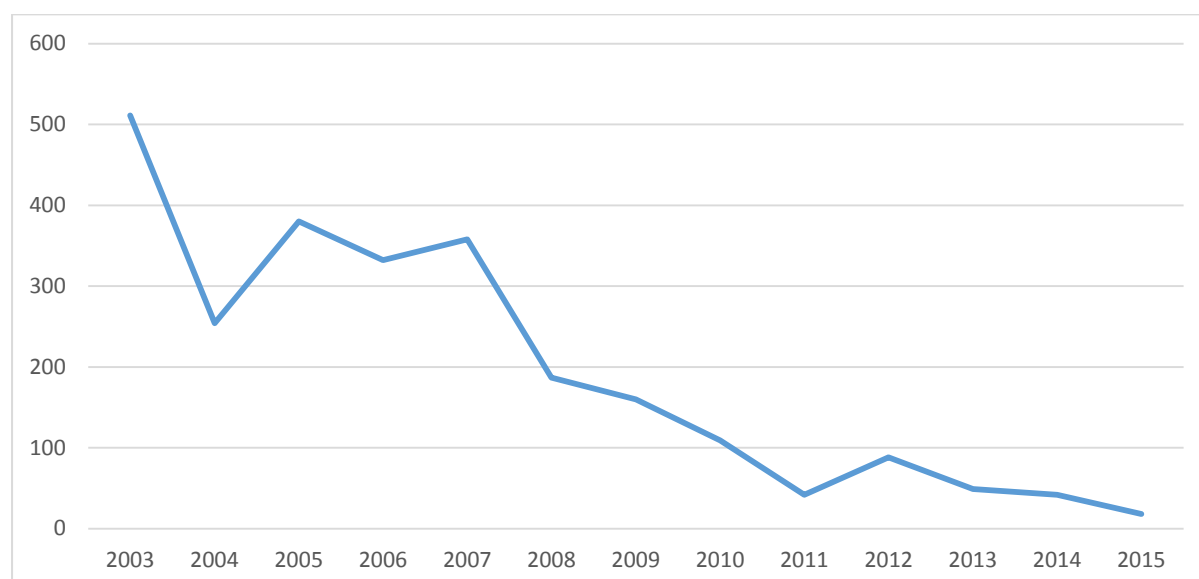
Figure 20 - Cracked or Broken Fishplates on the IÉ Network, by year.

A fishplate is a special bolted connection that joins two rails together. The trend for ‘Cracked’ or ‘Broken Fishplates’ continues on the overall downward direction seen over the last ten years. Following a small rise in 2012, a significant decrease was noted for 2013, with this trend continuing in 2014 and 2015. This decrease is attributable to the installation of continuous welded rail (CWR) under the Railway Safety Investment programme (1998-2013).

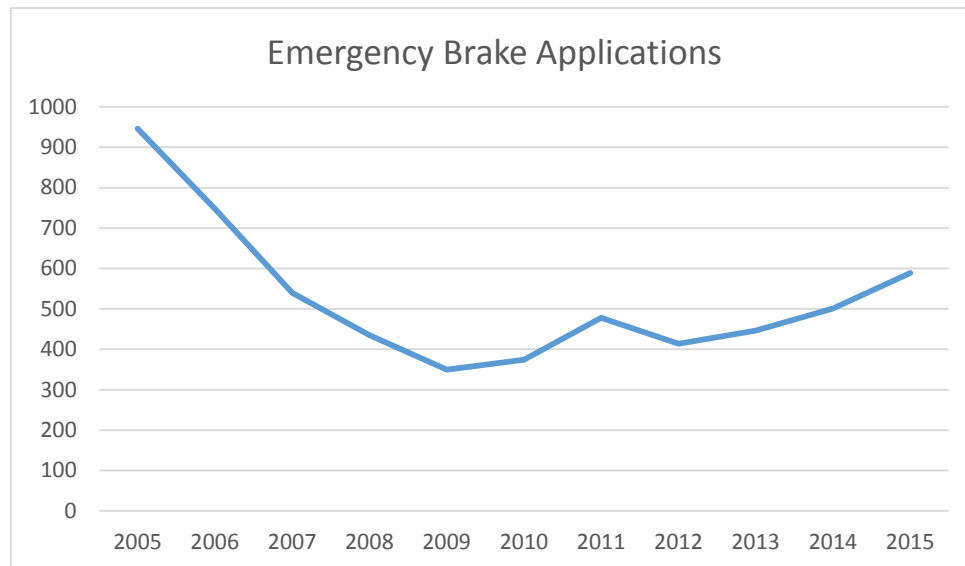
Figure 26 - Emergency Brake Applications

A useful indicator is the number of Emergency Brake (EB) applications which tram drivers make. In addition to its standard brakes, a tram is fitted with an electromagnetic track brake. Tram drivers are trained in defensive driving techniques and are constantly vigilant of pedestrians, cyclists and road vehicles. However, there are occasions when a driver may need to apply the EB to prevent a harmful incident.

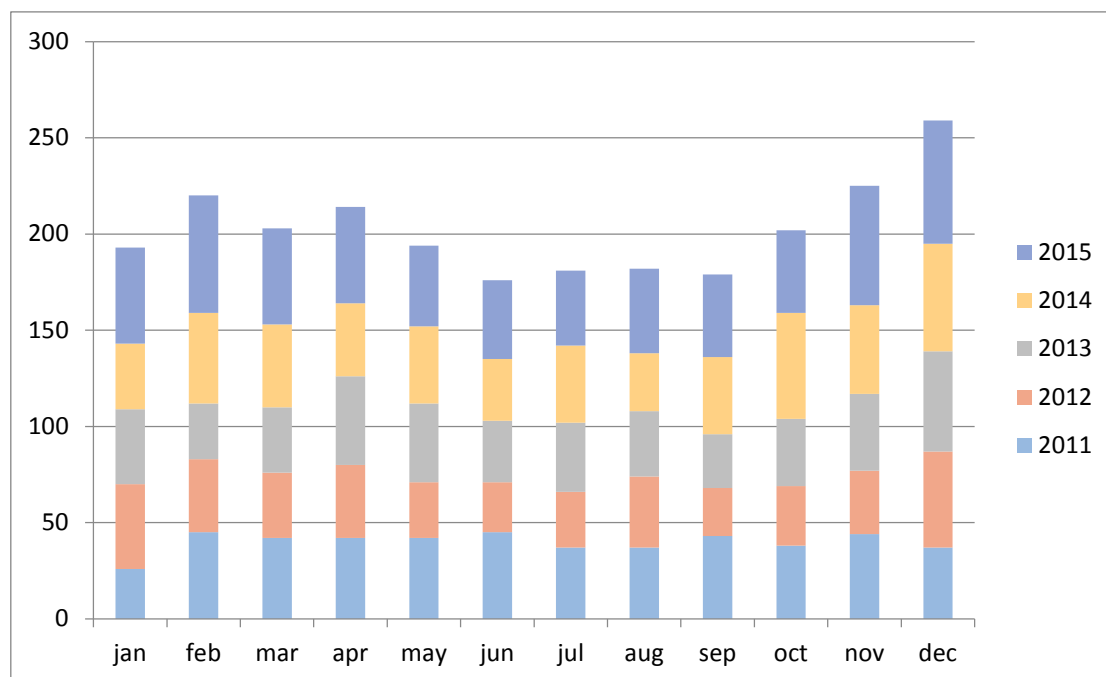
Figure 27 - Number of EB per 100,000 km travelled per month

Figure 27 below shows that when EB applications are normalised per 100,000 km travelled, it can be seen that the highest applications occur when the daylight hours are fewest, and school holidays occur, e.g. just before Christmas and the Easter holidays.

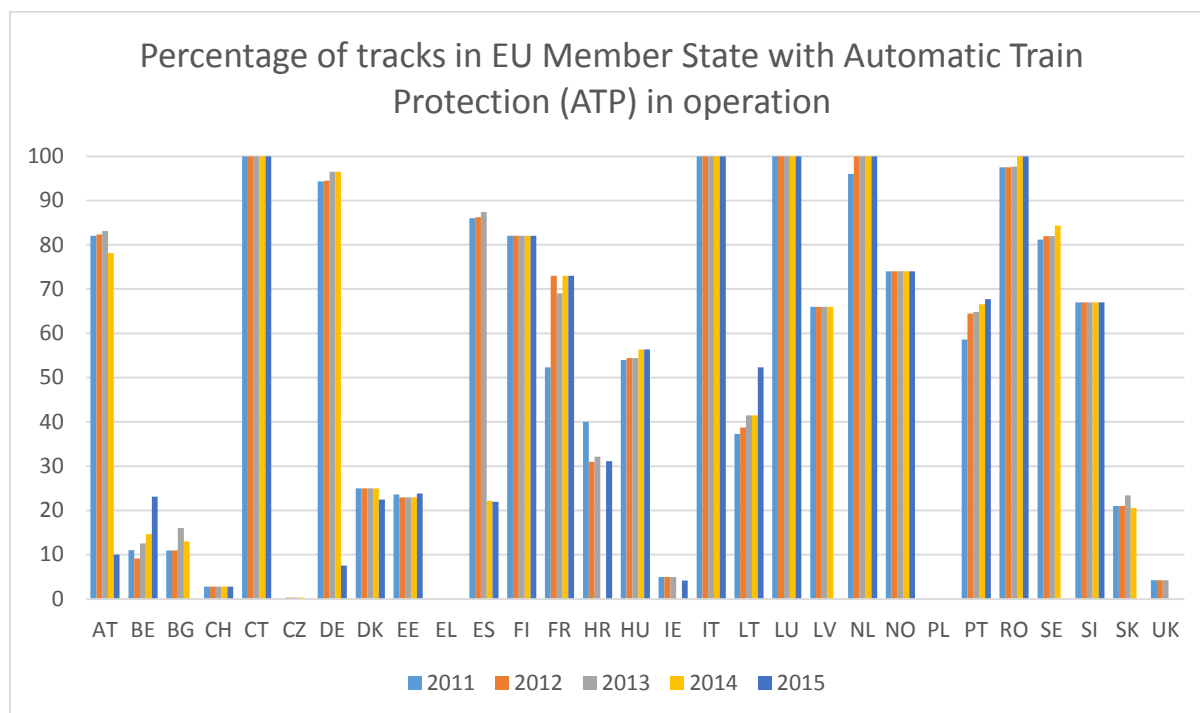
Figure 28 - Percentage of EU/EEA tracks with Automatic Train Protection (ATP) in operation, by country

United States the Federal Administration has mandated a form of ATP (known as Position Train Protection – PTP).
