# Post incident inspection following unsafe occurrences at Lavistown Level crossing. 29-31 March 2012

Issue	Prepared by	Checked by	Issue date
First draft	AJH	AB	19/05/12
Draft for Comment	AJH	AB	28/06/12
Finalised	AJH	AB	28/08/12

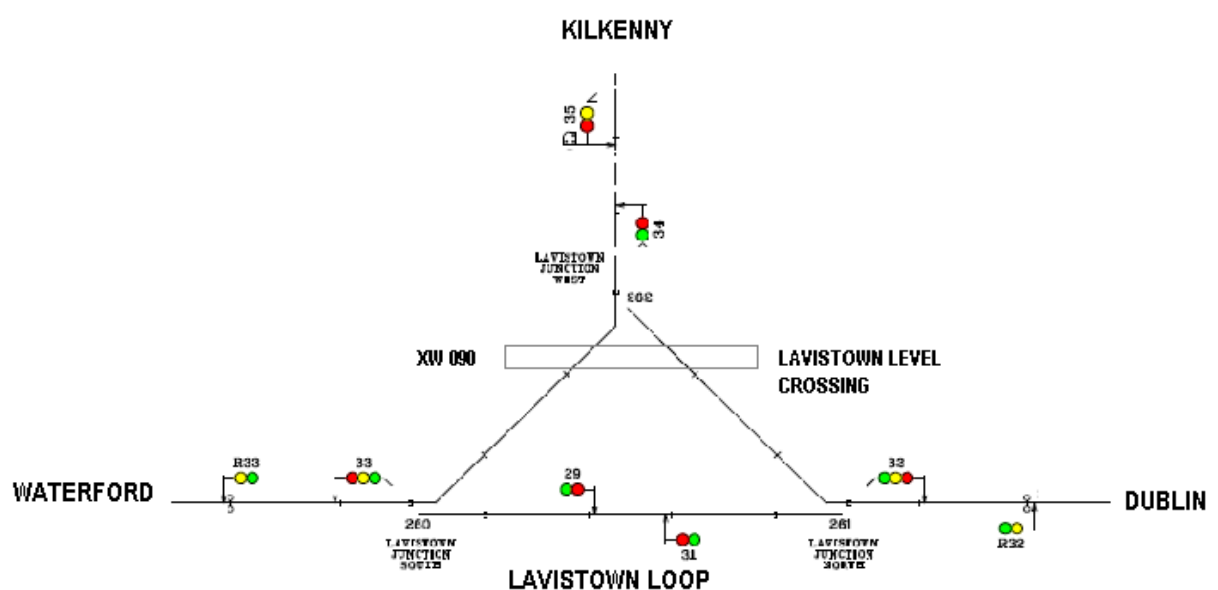
3.2-1 Schematic of track layout at Lavistown Junction

The incidents occurred on the Kilkenny - Waterford route, this is single track line which diverges from the Dublin Kilkenny line at Lavistown Junction. There is also a connecting loop between the two lines (shown in Figure 3.2-1).

Lavistown Level crossing (XW 090) dissects both the Kilkenny-Waterford and Dublin-Kilkenny lines. The crossing is located at 30m 1210yds on the Kilkenny-Waterford line and the linespeed at this location in normal service is 25mph.

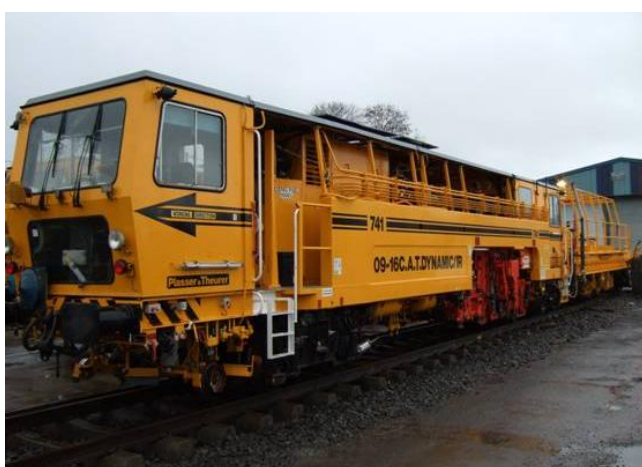
3.4-1 Plasser 09-16 continuous action tamper

The Vehicle (Train ID: Y741) involved in the incidents was an On Track Machine (OTM) consisting of a Plasser 09-16 continuous action plain line tamper with a Dynamic Track Stabiliser (DTS) trailer attached (See Picture 3.4-1). The vehicle was not equipped with an event recorder (TELOC). The date of manufacture is 1994. The machine consists of 3no. bogies and 7no. axles. The vehicle length is 17.1m and the trailer length is 10.8m.

No evidence was provided to indicate that there were any significant faults with the vehicle that contributed to the incidents that are the subject of this report
