Preliminary Post Incident Inspection

Incident: 140307 - Rushbrooke rock fall
176mp 100 yards

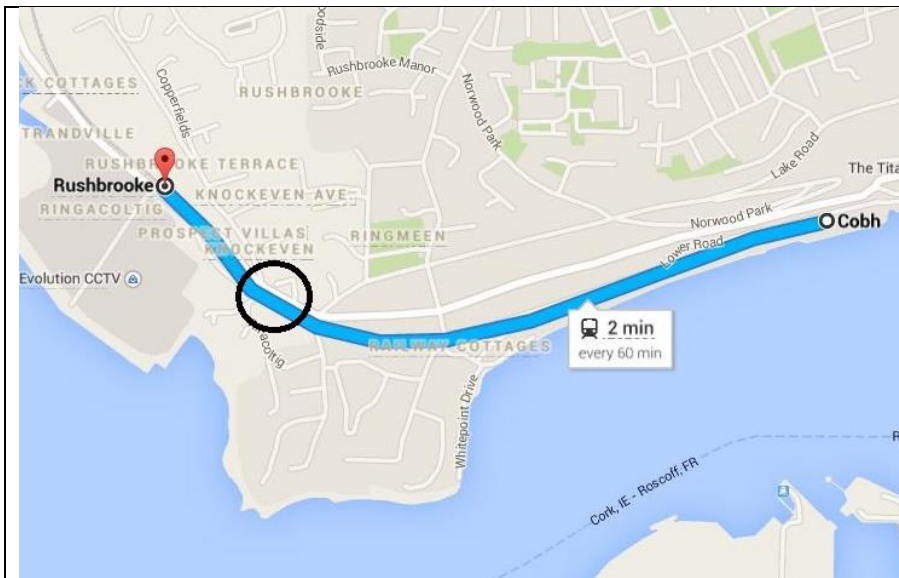
Figure 1 – Location map – (circle indicates the location of the rockfall)

The incident happened 500 yards south of Rushbrooke station at 176miles and 100 yards on the Cork-Cobh Down line between overbridges OBC434 & OBC435. (See figures 1-4)
