Railway Safety Performance 2014

21st October 2015

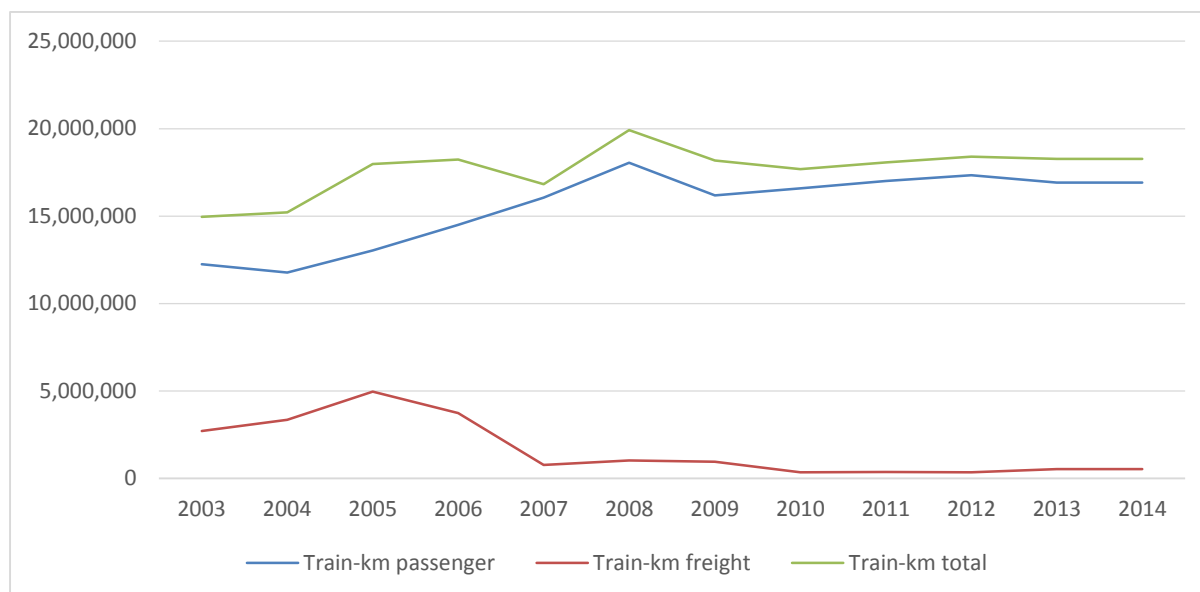
Graph 3-2 Train-km on the Iarnród Éireann Network 2003-2014

The long term trend for reduced freight movements is quite evident in Graph 3-2. A peak of about 5,000,000 train-km was reached in 2005 but this declined rapidly afterwards following strategic operational decisions which reduced freight traffic. At about this time, passenger-km soared and peaked in 2008. Iarnród Éireann is currently endeavouring to expand freight services following several years of decline in the previous decade, with some evidence from data indicating small growth.

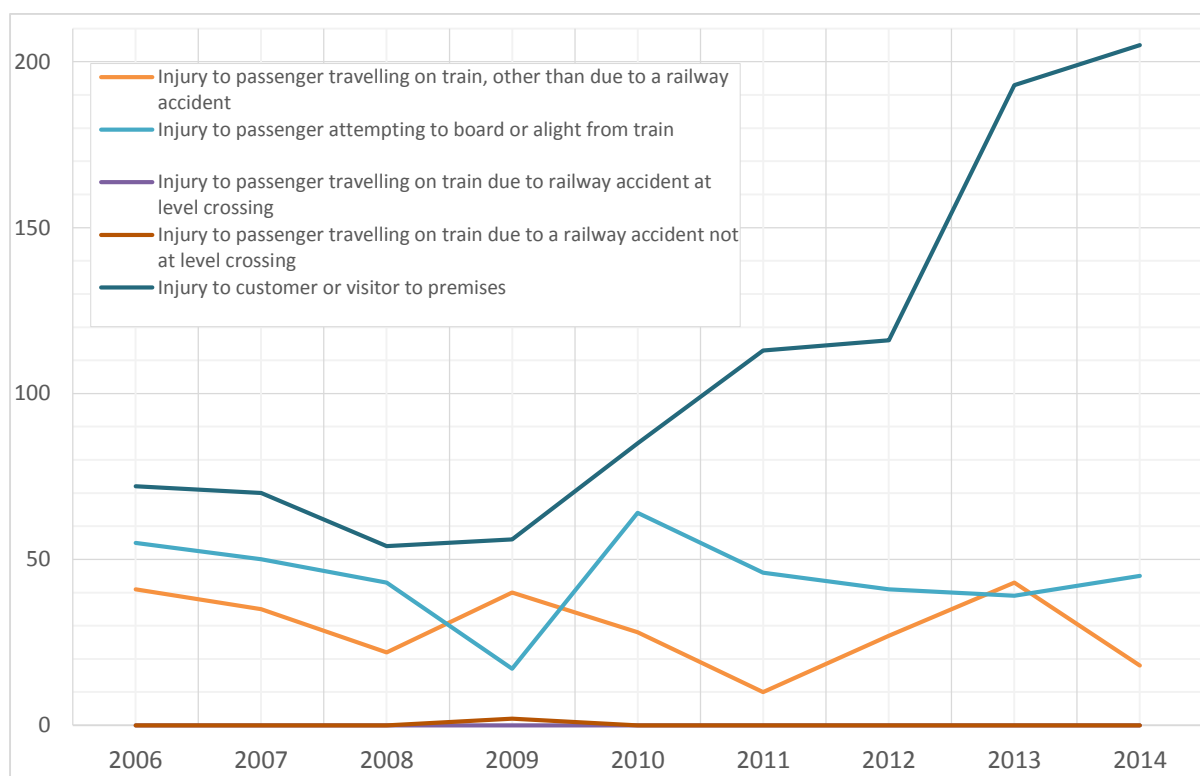
Graph 3-4: Passenger Injury statistics by year

Similar to other years, injuries to customers or visitors to stations remain at a high level with slips, trips and falls being the dominant cause of these injuries. These incidents tend to be of a minor nature and are usually treated by first aid at the station. IÉ report usage of mobile phones

Injuries to passengers attempting to board or alight from trains has seen a small increase but remains a cause for concern owing to the high risk of significant injury from this type of incident. IÉ has undertaken much activity in this area in the form of an assessment of systems that prevent accidents. In addition, the RSC is undertaking a long term study on this type of incident.

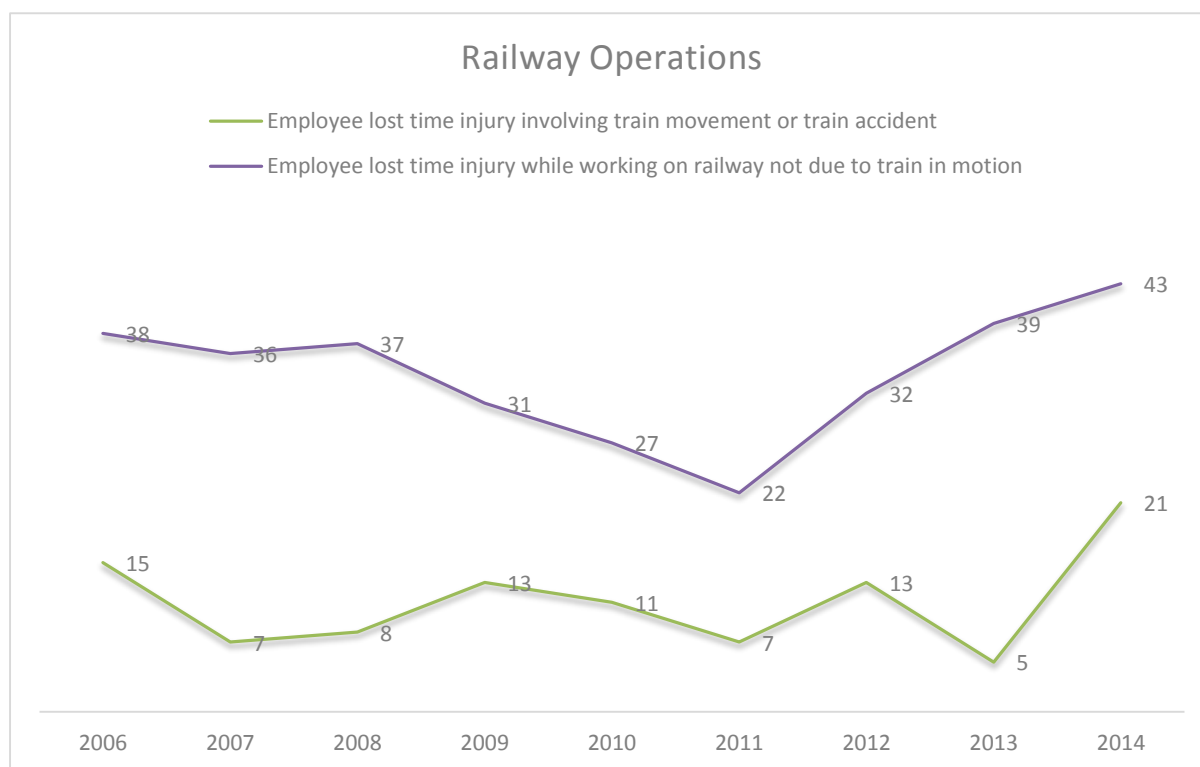
Graph 3-5: Employee Injury statistics by year (Railway Operations)

The significant rise in Lost Time Incidents involving train movements is due to more staff reporting psychological trauma after serious accidents and fatalities. Increases to non-train movement incidents has been traced to improved reporting arrangements arising from further improvement of the Railway Organisation's Safety Management System.

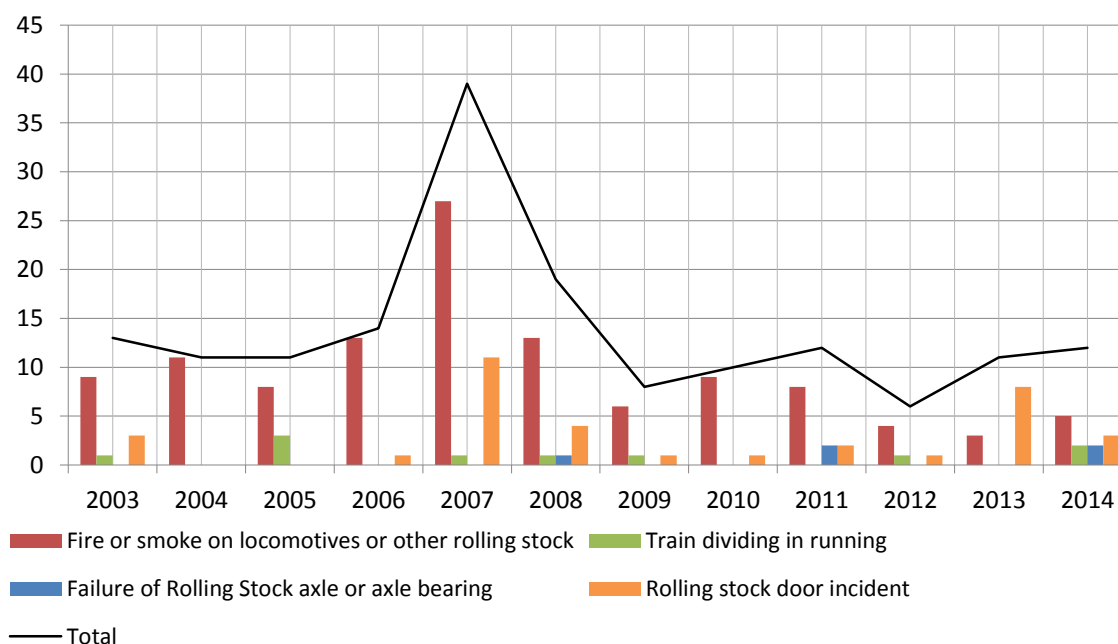
Graph 3-15: Rolling Stock Incidents by year

The number of reportable rolling stock incidents increased slightly in 2014. The broad trend, over a ten year period is in the main positive. Rolling Stock safety performance of the various fleets for 2014 is following a somewhat expected trend, following various problems associated with several fleet introductions from 2003 onwards.

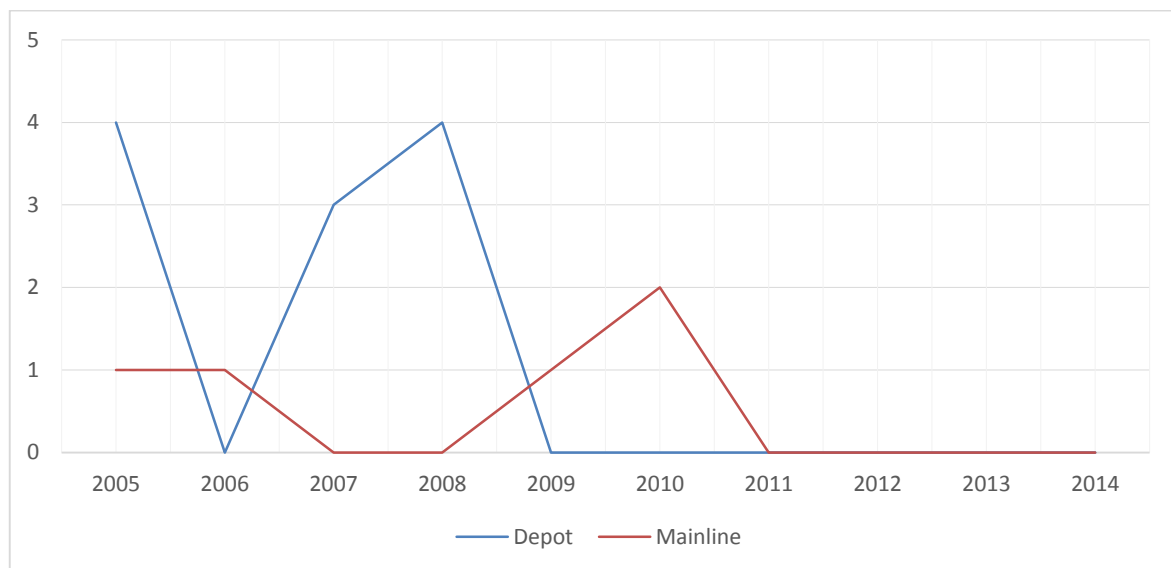
Graph 3-22: Tram Derailments

No derailments were reported in 2014.
