AN COIMISIÚN UM RIALÁIL IARNRÓID
COMMISSION FOR RAILWAY REGULATION

RAILWAY SAFETY PERFORMANCE IN IRELAND 2021

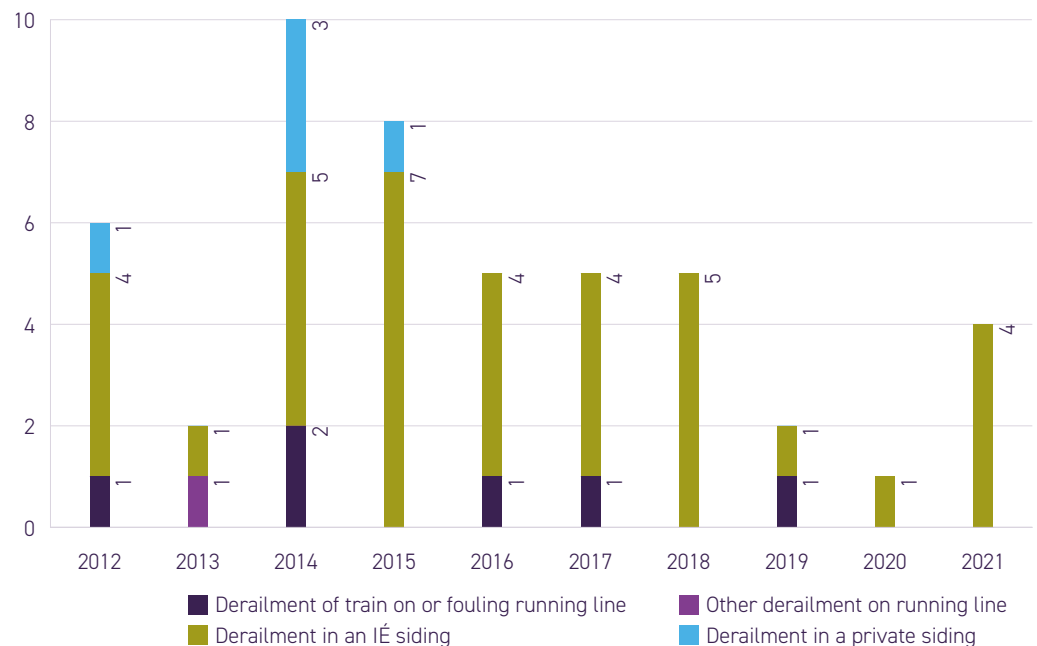
Figure 13
Train derailments
by year

The number of train derailments increased from a record low of 1 in 2020 to 4 in 2021 (Figure 13). The derailments were all located off of the running line, i.e., in a siding, some are still under investigation for cause but provisionally the causes vary from vandalism & misuse of hand points (manually operated switches located in low-speed sidings/yards) to sub-optimal maintenance processes being in place for track located off of the main line.

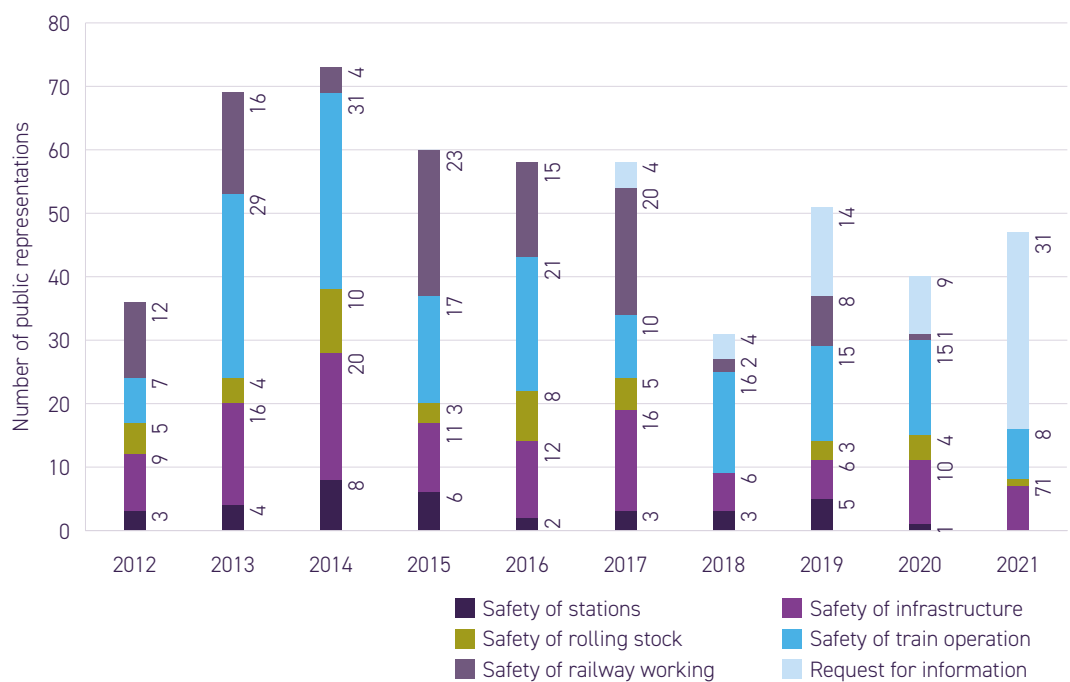
Figure 28
CRR public
representation
by category

The numbers of representations/requests for information by category are shown in Figure 28. The primary focus of the CRR is with the 16 safety related representations, which have decreased across all categories. These concerns ranged from the structural safety of bridges to the operation of trains outside of approved instructions.

Note that requests for information are not counted towards the overall figure.
