AN COIMISIÚN UM RIALÁIL IARNRÓID
COMMISSION FOR RAILWAY REGULATION

RAILWAY SAFETY PERFORMANCE IN IRELAND 2023

This is the fifteenth Annual Safety Performance report produced by the CRR, prepared for the use of stakeholders and the general public. This report presents a number of high-level statistics and safety performance indicators, with associated commentary on their significance. These safety performance indicators are based on the Common Safety Indicators (CSI) defined in EU Directive 2016/798 for conventional heavy rail systems. For light rail systems (such as the Luas) and Heritage Railways (those solely for historical or tourist use) additional indicators are used to analyse the risks deemed to be particular to those sectors in Ireland. (See sections 2.5-2.7 for further detail).

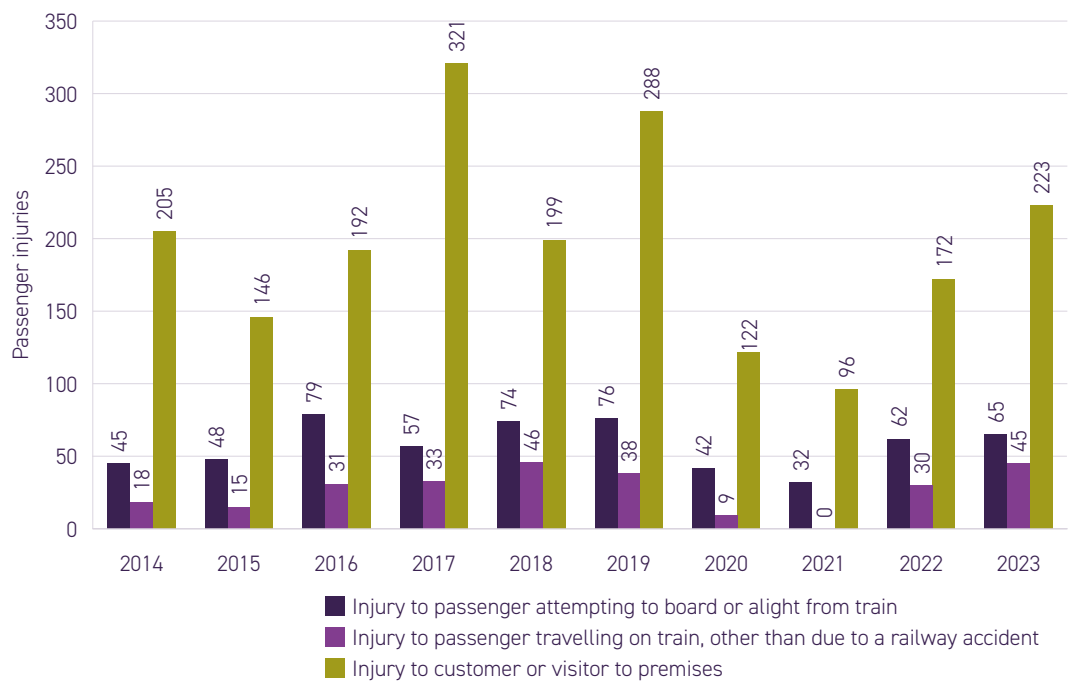
Figure 5
Passenger injury
statistics by year

In line with European trends, the largest proportion of incidents occur to persons during time spent at stations as opposed to time spent on trains and in 2023 this was no different. 45 injuries were reported by passengers travelling on a train in 2023, which is a 50% increase on 2022. Injuries to a customer or visitor to premises also increased by 10% year-on-year and remains the largest single category of injuries with slips, trips and falls of various sorts being the dominant cause of these injuries. IÉ-RU initiated some passenger safety actions in 2023 on foot of increasing trends which included proactive use of social media to alert customers to Platform Train Interface risks and winter readiness plans for all stations.

Note: Injury to passengers travelling on a train due to a railway accident at/not at level crossing is not represented due to being consistently 0 in the last 10 years

In general, the numbers of injuries in all categories are in line with pre-2020 trends and as such an improvement (or worsening) in safety performance over the last 4 years cannot be determined.

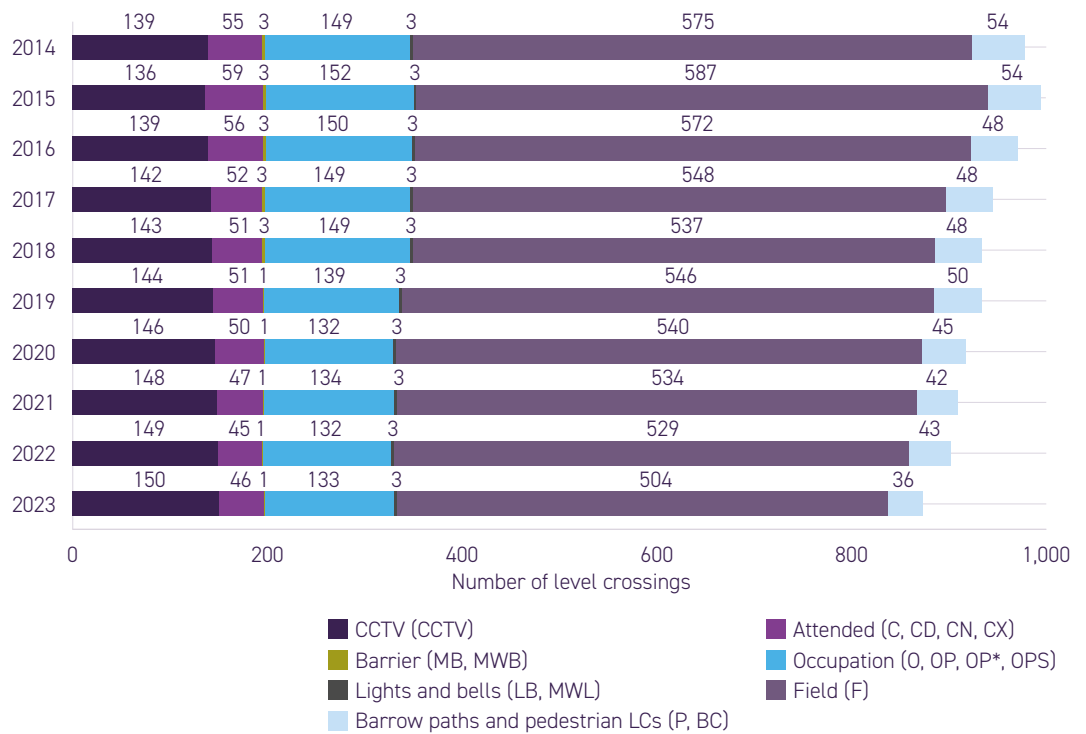
Figure 12
Level crossings by
type in Ireland

The breakdown of level crossings by type and year in Ireland is shown in Figure 12. Occupation level crossings on public roads, that is those that require the road user to manually open and close gates, remain the highest risk type of level crossing, closely followed by similarly gated 'Field type' level crossings which are those a farmer might use if they have private land on both sides of a railway. IÉ-IM have continued to install further DSS 'Decision Support System' equipment on their highest risk user worked level crossings. The DSS is a set of visual and audible warnings installed at the crossing to warn users of an approaching train. A broadly similar system ('Miniature Stop Lights (MSLs)') is being installed at crossings in the UK by Network Rail.

Figure 12 also demonstrates how the higher risk Occupation and Field type crossings have reduced in number while the lower risk CCTV type has increased in line with IÉ's risk management strategy. In the ten years to the end of 2023, CCTV type crossings have increased whilst other, higher risk, crossings have reduced. In addition to this, the rate of removal of crossings is also increasing slightly over a rolling ten years. As a result, the share of total crossings on the network which are CCTV type has increased from 14% to 17% over 10 years.

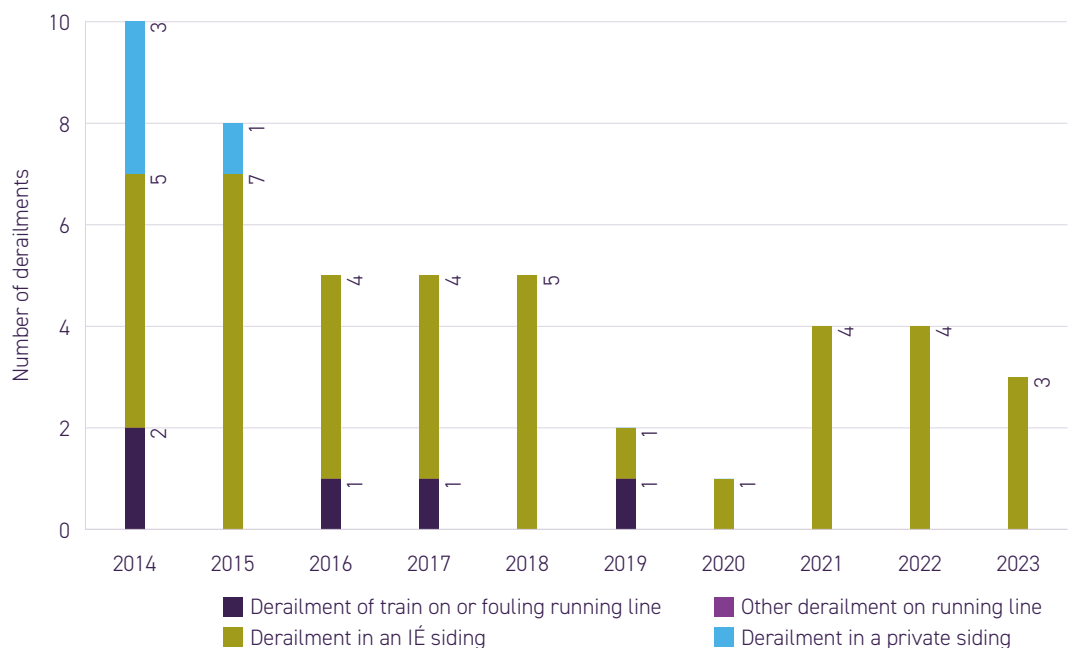
Figure 13
Train derailments
by year

There were three train derailments in 2023, which is one less than 2022 (Figure 13).

The derailments were all located in sidings. The causes of these derailments are still under investigation by the investigations team of the railway organisation and the Compliance, Supervision and Enforcement team of the CRR undertake post occurrence activities and oversight of these railway organisation investigations via periodic meetings. As all derailments were in sidings and not on live railway, as a result these derailments have a lower associated risk profile.
