AN COIMISIÚN UM RIALÁIL IARNRÓID  
**COMMISSION FOR RAILWAY REGULATION**

# RAILWAY SAFETY PERFORMANCE IN IRELAND 2024

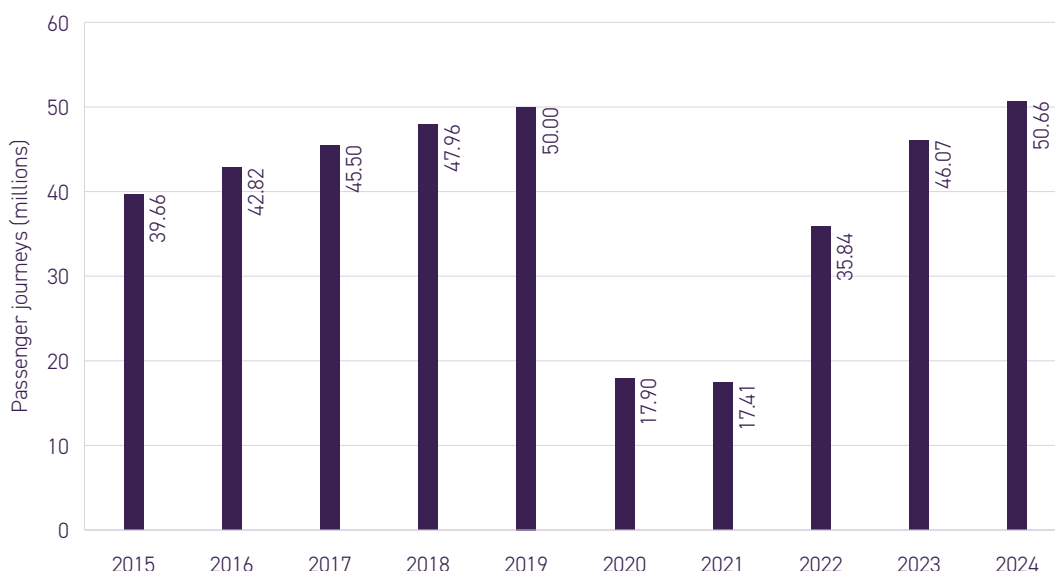
Figure 1  
IÉ passenger journeys

Figure 1 shows passenger journeys continued to increase in 2024, exceeding pre-COVID-19 levels and set a record high. An Irish Rail report contributes this to a move from hybrid working to increased office attendance, major events in Dublin, and the increase in services to Belfast, Galway and Waterford.<sup>2</sup> A further increase in 2025 is expected.

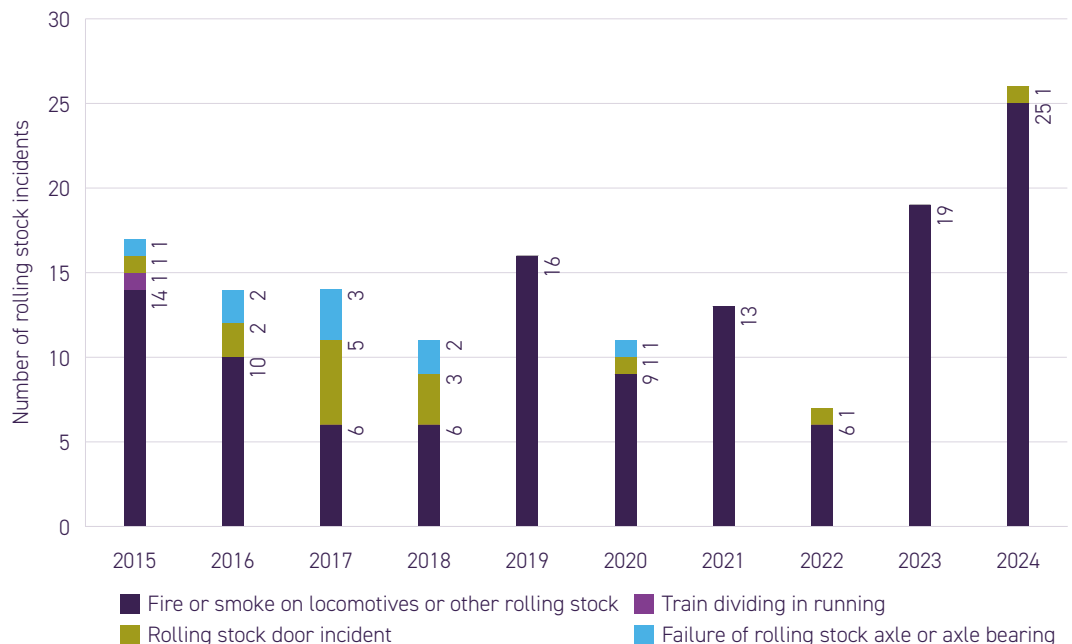
Figure 15  
Rolling stock  
incidents by year

Figure 15 shows several key safety performance indicators pertaining to rolling stock, specifically:

- Fire or smoke incidents
- A train dividing (parting) while in service
- Failure of rolling stock axle bearing
- Door issues.

Fire and smoke related incidents increased again in 2024 to its highest level since 2017. When considered over a 10-year period the average number of smoke/fire incidents per year is showing an upward trend. 9 of the 25 incidents were categorised as fires, and occurred on 29000 DMU's (6), Mark IVs (2) and 22000 DMU's (1). Incidents of smoke were attributed to 29000s in the main, however 6 incidents occurred on Mark IVs. In general, these were caused by fuel and oil leaks. In 2024, IÉ-RU CME completed a bow tie analysis of smoke/fire events. An improvement process was subsequently developed to increase the reliability and reduce the potential of smoke/fire incidents on the 29000 fleet. The CRR is monitoring the implementation of these improvements at periodic meetings. The result of this process will become evident over time.

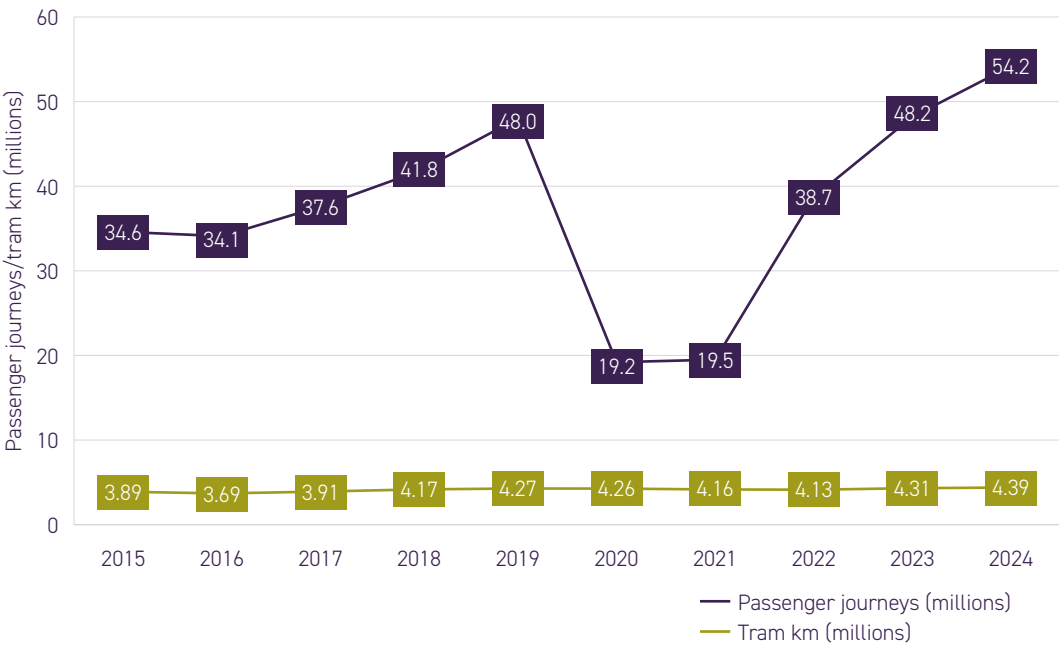
Figure 19  
Luas passenger  
journeys and  
tram-km travelled

The Luas is comprised of two lines, the Red Line which is 20.5 kms in length and has 32 Stops and the Green Line which is 24.5 km in length and has 35 Stops. Figure 19 shows passenger journeys in 2024 were a record number for the Luas, surpassing 54 million, an increase of 12.5% from 2023. Tram kilometres also increased to a record 4.39 million vs 4.31 million in 2024.
