AN COIMISIÚN UM RIALÁIL IARNRÓID  
COMMISSION FOR RAILWAY REGULATION

# RAILWAY SAFETY PERFORMANCE IN IRELAND 2021

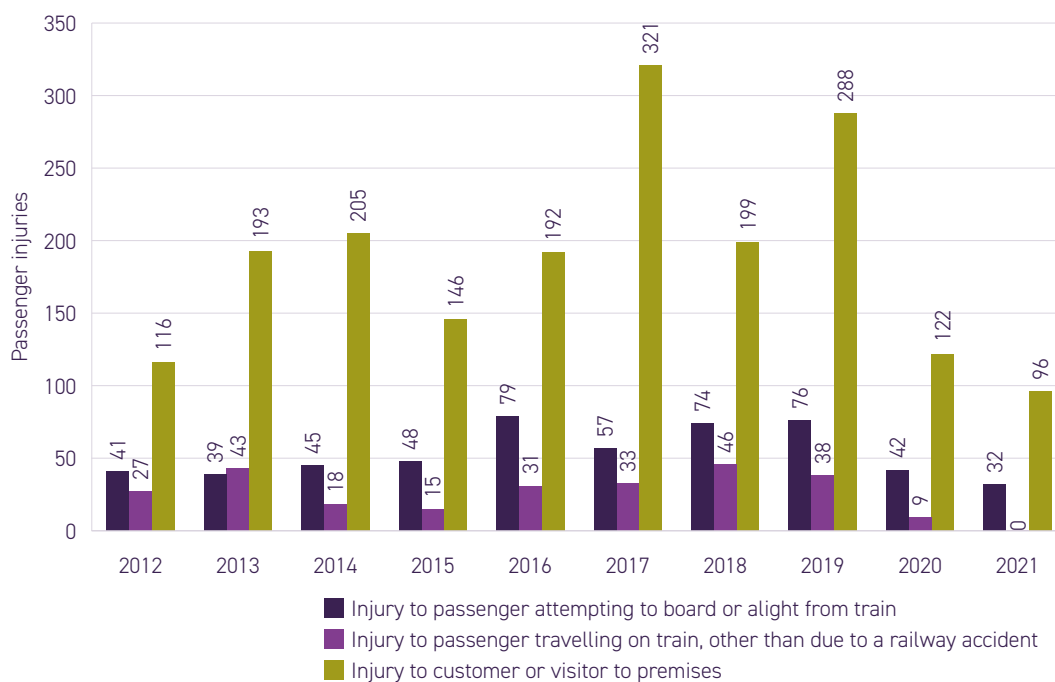
**Figure 5**  
Passenger injury  
statistics by year

Note: injury to passengers travelling on a train due to a railway accident at/not at level crossing is not represented due to being consistently 0 in the last 10 years.

Injuries to persons (customers or visitors) on railway premises remain the largest single group with slips, trips and falls of various sorts being the dominant cause of these injuries. The reduction in numbers for 2021 is more in line with the real reduction in passenger journeys than it was for 2020, which indicates that the risk to the individual is no higher than it was in 2019. The interface between the station platform and the train is the most dangerous area for passengers on the Iarnród Éireann railway network and unfortunately the reduction in harm here has not been proportional to the reduction in passenger numbers, indicating a slight drop in safety performance.

In line with European trends, the largest proportion of incidents occur to persons during time spent at stations as opposed to time spent on trains and in 2021 this was no different. No injuries, for any reason, were reported by passengers travelling on a train in 2021, continuing the trend in railway accident categories. However, as explained earlier, the reduced passenger journeys are very likely a factor in the reduction of injuries to passengers travelling on a train, other than due to a railway accident, evidenced since 2019.

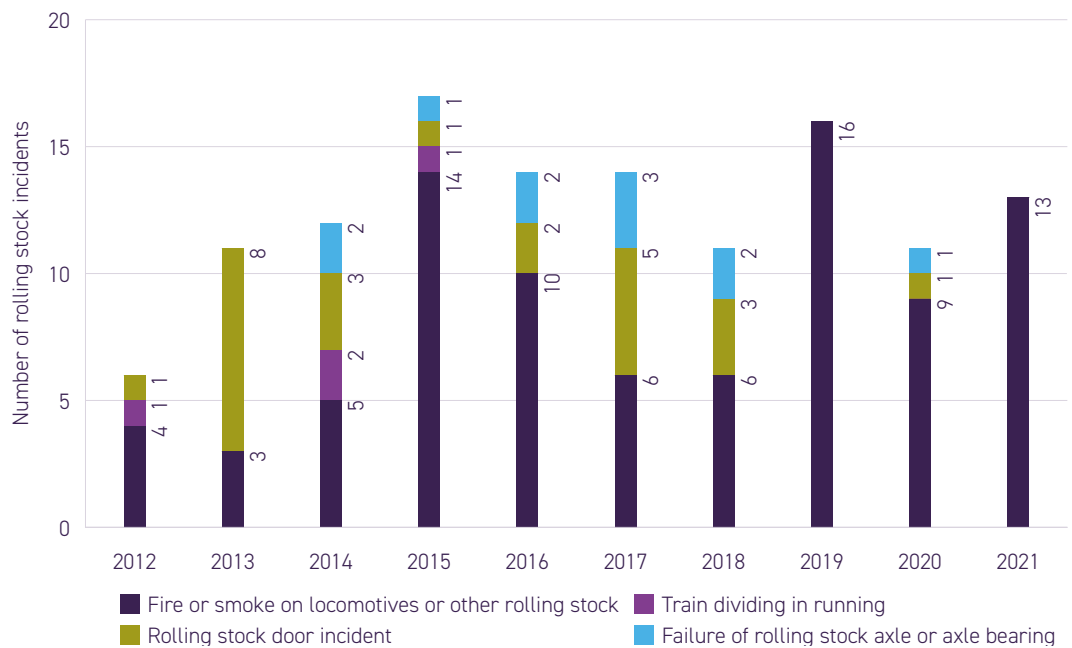
**Figure 15**  
Rolling stock  
incidents by year

In 2021, all incidents were of the fire or smoke category, 3 of which were reported as fire and 10 reported as smoke. Eleven of the 13 were attributed to rolling stock that utilises internal combustion engines and relating to their relative complexity and use of combustible fuels and lubricants. In many of the events the failures are reliability issues (failed gaskets, pipes, and internal components) which manifested as fire/smoke when combustible fluids made contact with hot engine components. There is a concern with the number of incidents associated with the 29000 DMU Fleet, given all of the fire incidents and 6 of the smoking incidents occurred on 29000's. Whilst it is likely that much of this is due to the design of the 29000 allowing reliability issues to manifest as fire/smoke (multiple internal combustion engines, closely packaged with leak sources directly above hot engine parts), the maintenance practices applied to the 29000's in one of the aforementioned fire incidents did however result in the CRR flagging 29000 maintenance for further investigation. The 29000s are equipped with automatic fire suppression and utilise fire barriers to minimise the risk of harm to passengers in the event that a fire does break out during a journey.

There are a number of key safety performance indicators pertaining to rolling stock (Figure 15), specifically:

- Fire or smoke incidents
- Failure of Rolling Stock Axle Bearing
- A train dividing (parting) while in service
- Door issues.

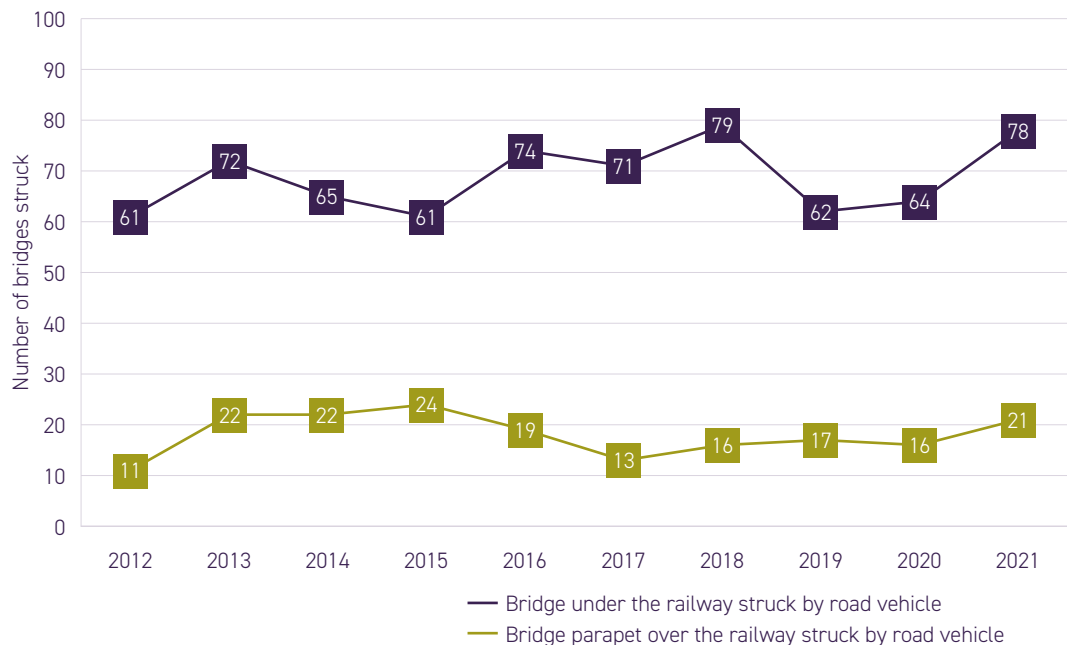
**Figure 18**  
**Railway bridges struck**  
**by road vehicles**

Performance has noticeably declined since 2012. There are a multitude of factors that may be driving this increase, possibly related to the change in human behaviour as a result of the pandemic. Review of the data provides evidence that much of the strikes are happening multiple times on the same bridges, in some cases a single bridge can record double digit numbers of strikes in a single year. In addition to the CRR issuing outcomes to the infrastructure manager in 2021 to improve the management of bridge strikes, these particular multi-strike bridges are readily identifiable to the infrastructure manager and action is being taken to address them, although in some cases the fixes are not straightforward and require considerable coordination and planning with local authorities.

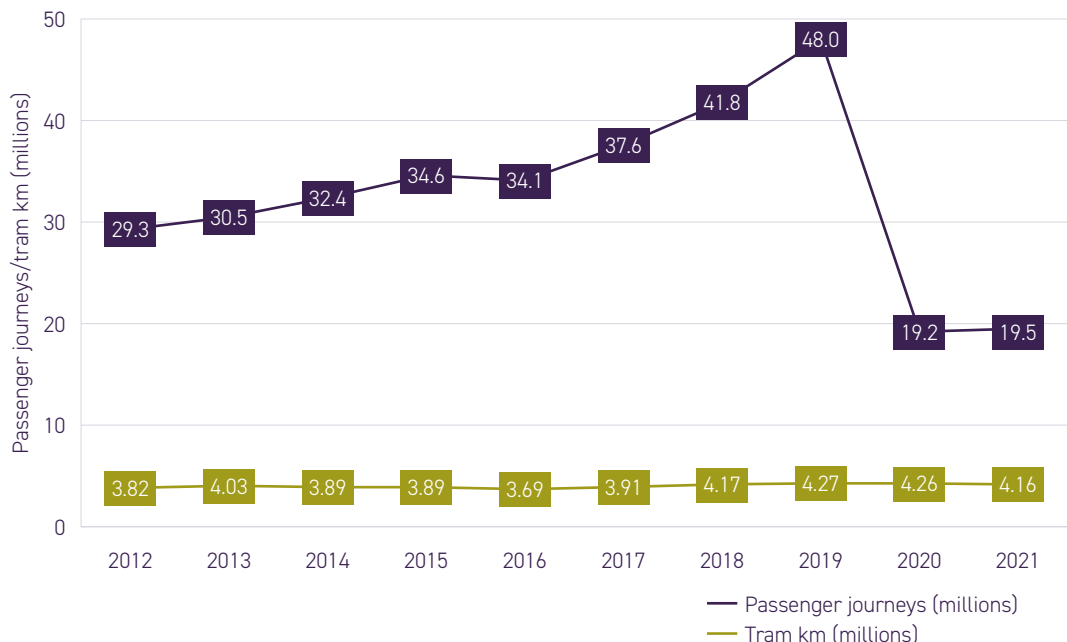
**Figure 19**  
Luas passenger  
journeys and  
tram-km travelled

The Luas comprises two lines, the Red Line which is 20kms in length and has 32 Stops and the Green Line which is 24.5kms in length and has 35 Stops. In line with 2020, public health measures for COVID-19 continued to cause a large decrease in usage of the service. 19.5 million journeys were recorded, a marginal increase on 2020's total of 19.2 million. Tram kilometres travelled did drop slightly, with 4.16 million reported in 2021 versus 4.26 million in 2020 (Figure 19).

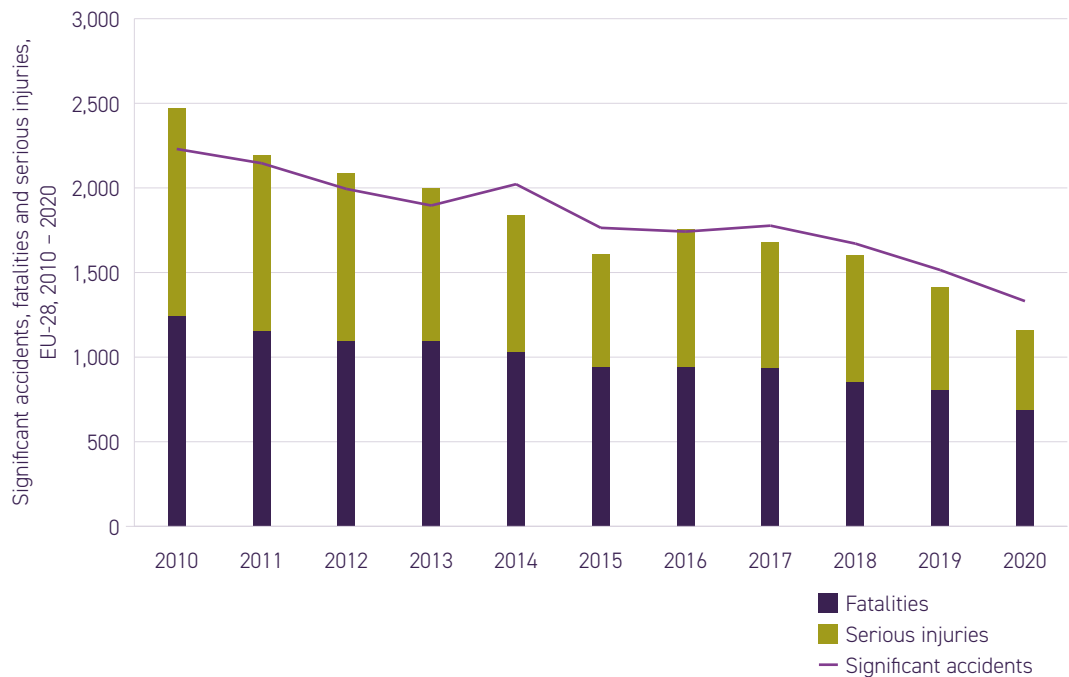
**Figure 29**  
Significant accidents,  
fatalities and serious  
injuries of EU 27,  
2010 – 2020

The Railway Safety Directive (Directive (EU) 2016/798) defines a significant accident as “any accident involving at least one rail vehicle in motion, resulting in at least one killed or seriously injured person, or in significant damage to stock, track, other installations or environment, or extensive disruptions to traffic, excluding accidents in workshops, warehouses and depots.” In 2020 (the most recently available dataset), there were 1331 significant accidents resulting in 687 fatalities and 469 serious injuries within the European Union (Figure 29).

The annual number of significant accidents has decreased steadily over the 10 years up to 2020. With a statistically significant year-on-year 12% decrease in significant accidents between 2019 and 2020. ERA have observed a decrease across all accident categories both year-on-year and against the average of the four preceding years except for collisions and other accidents. Collisions of trains and ‘other’ accidents increased in 2020 compared with 2019 and the preceding four-year average.

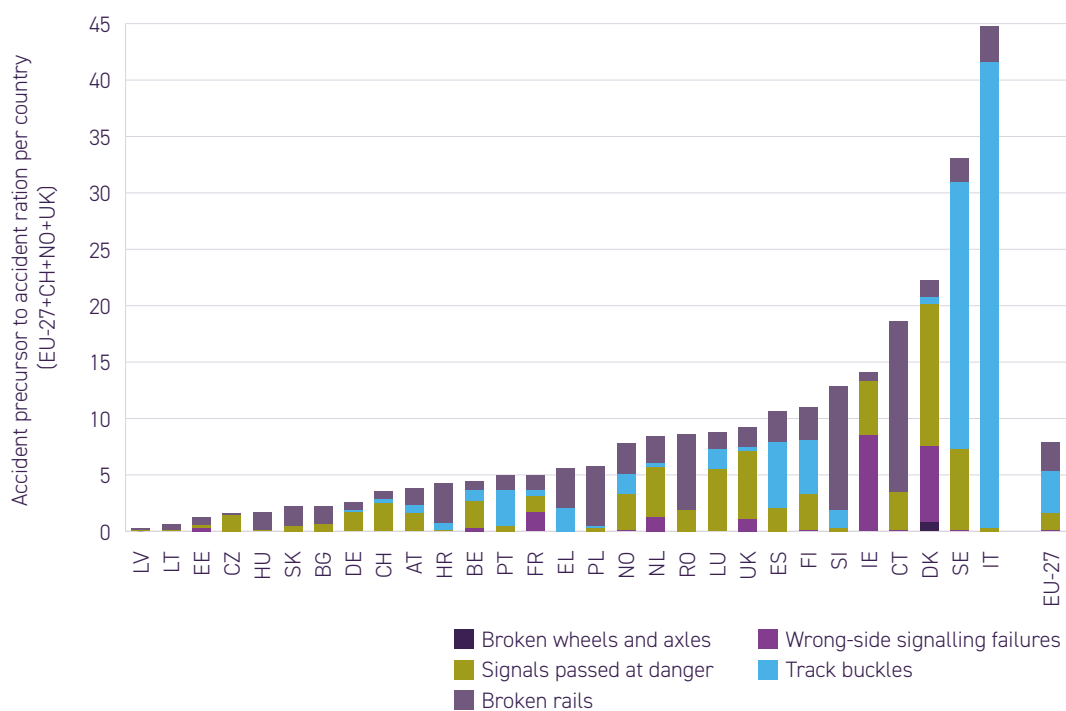
**Figure 34**  
Total precursor  
events by country,  
2016 – 2020

As seen in Figure 34, Ireland is at the higher end of the scale in terms of the ratio of accident precursors to accidents. It is the case that, as this metric measures the ratio of accident precursors to accidents, Ireland shares the high end of the scale with other low accident rate countries. Performance could be compared by reviewing the relative performance of similar countries or by identifying areas of relative weakness. ERA report that they have concerns about data quality, hence it is difficult to draw a meaningful conclusion from the data shown.
