Railway Safety Performance in Ireland

Commission for Railway Regulation
21/12/2017

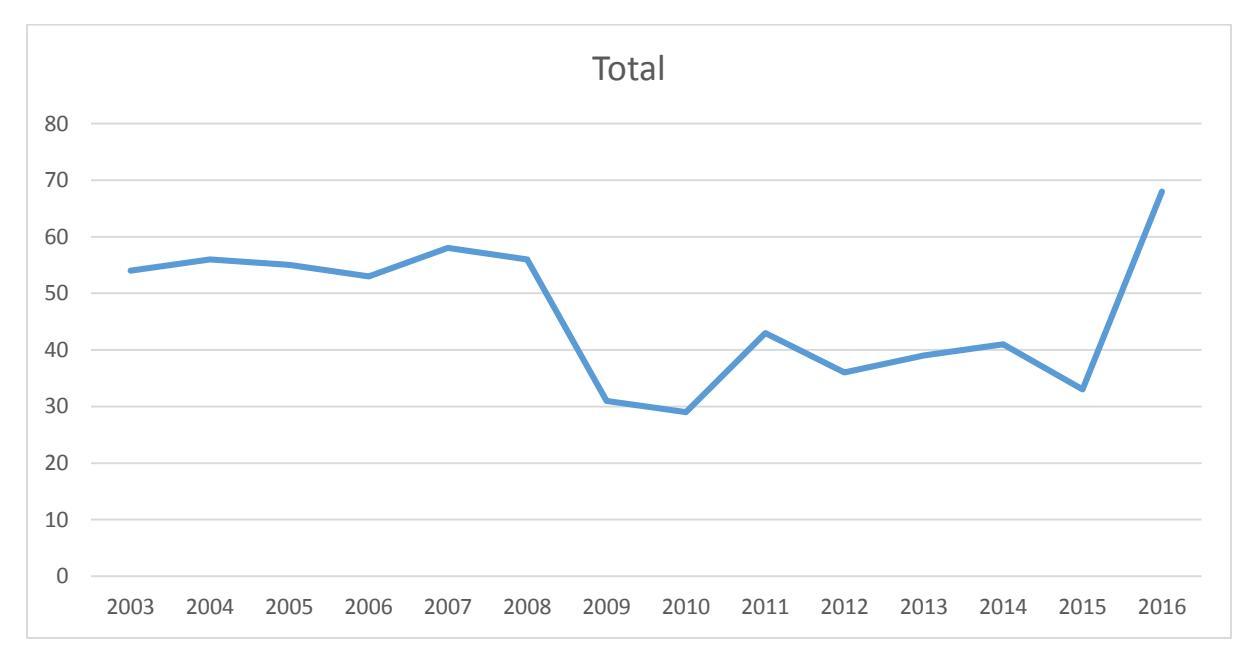
Figure 11 - Total Collisions by year

Train collisions can pose a significant risk to passengers, train crew and third parties. They have the potential to cause significant human and environmental harm. Figure 11 illustrates the trend for collisions since 2003. Figure 11 is supported by Figure 12 & 13 to aid understanding of the data. Two categories, 'Total Collisions with Obstacles on the line' and 'Train Collisions with animals (large)', have been separated to enhance visibility of the data as in isolation is of limited benefit. It does however illustrate a significant increase in 2016.

Total train collisions (with obstacles/large animals) have risen to 68 in 2016 from 33 in 2015. There has been some volatility in the data between 2013 and 2016, but the trends show it continues to be a cause for concern. As discussed in previous reports, animals, (deer, cattle and sheep) are a major contributor to collision statistics in Ireland. Iarnród Éireann continues

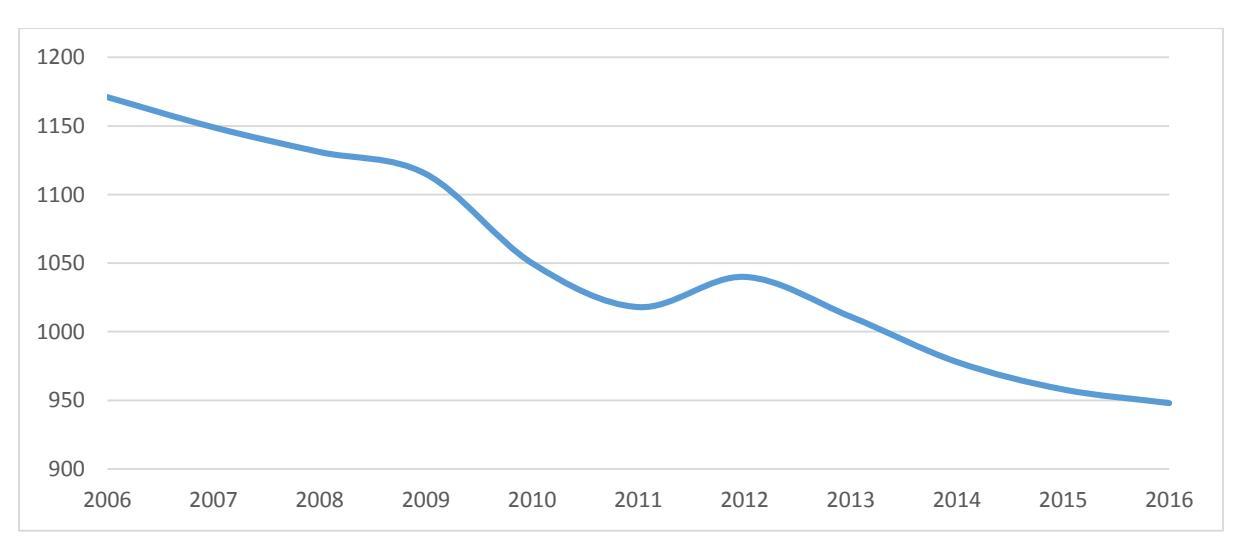
Figure 14 - Number of level crossings by year

Figure 14 illustrates the varying number of level crossings on active lines, i.e., not on closed or out of use lines.

Level crossings are a significant risk to the railway and to any third parties who use them. The long established trend, as shown in Figure 14 and Figure 15 is a decrease in the number of level crossings; there were 1701 level crossings in 2004 vs 948 recorded for 2016, with 23 being eliminated in 2016.

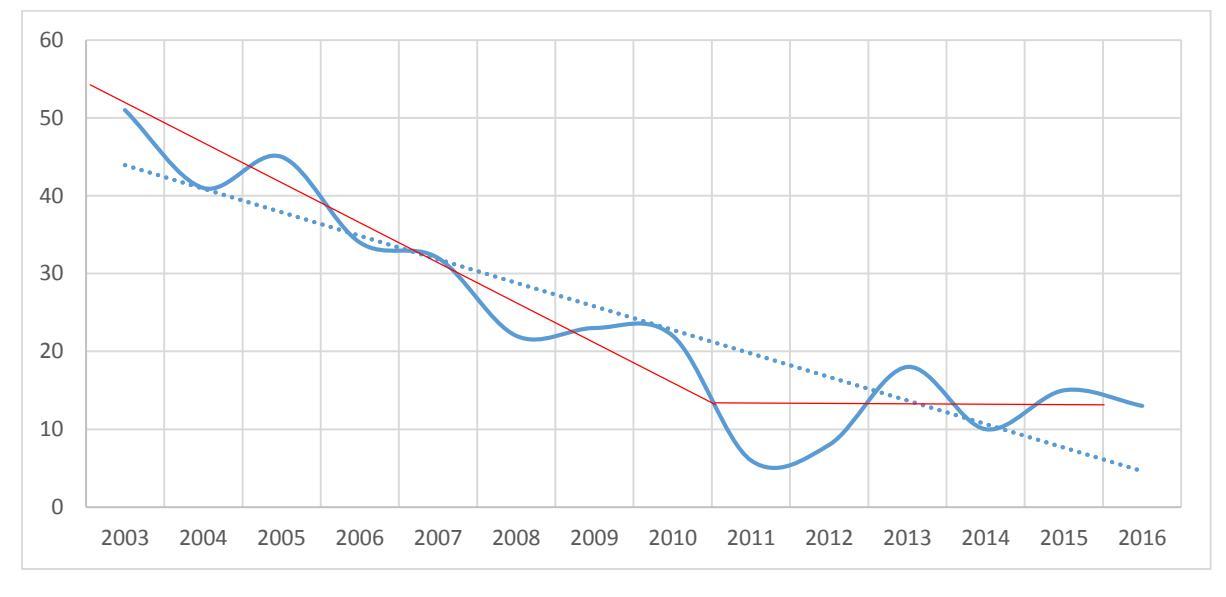
Figure 16 - IÉ SPADs by year

A SPAD is defined as having occurred when a train passes a stop (red) signal without authority. SPADs are a particular precursor event that the CRR monitors regularly during its supervisory meetings with IÉ. The trend in recent years has been a steady decline, but has started to rise again since the low of 2011.

IÉ use a ranking tool developed in Great Britain by an industry body to determine whether each SPAD had the potential to cause an accident. A significant amount of information relating to each SPAD is collated. Using this information, IÉ determine a weighted numeric score for each occurrence and the score dictates the level of internal investigation. SPADs are categorised by type and are grouped into one of 3 severity bands; Low Risk; Medium Risk; and High Risk. The trend is being monitored as part of specific supervision activities by the CRR, However, since 2011 the number of SPADs have essentially plateaued.

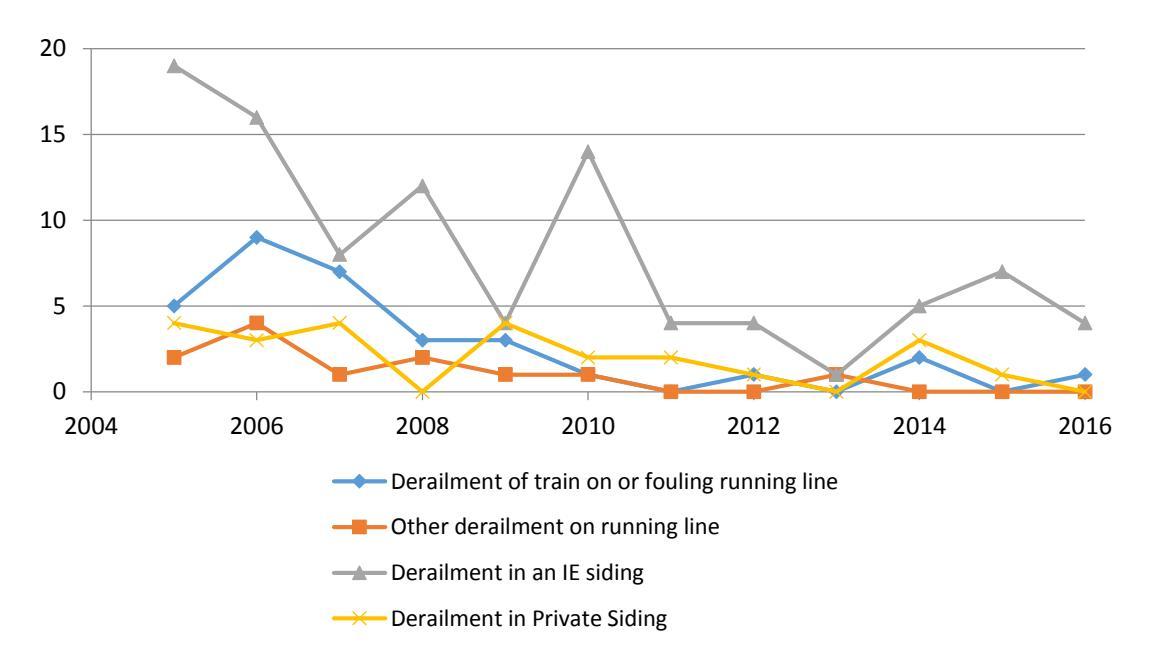
Figure 17 - Train Derailments by Year

Train derailments remain at low levels. Routine track inspection and maintenance are important activities that reduce the likelihood of derailment occurrences. Similarly, vigilance by railway employees who work in sidings together with safe systems of work that are understood by railway staff has the potential to reduce the number of occurrences of this type.

The rising trend of derailments in IÉ Sidings from 2013-15 has reversed. These derailments are typically minor in nature and low risk, nonetheless they will continually monitored by the CRR. IÉ had committed to auditing safety systems for train operations on sidings, and it is expected this will continue to improve indicators.

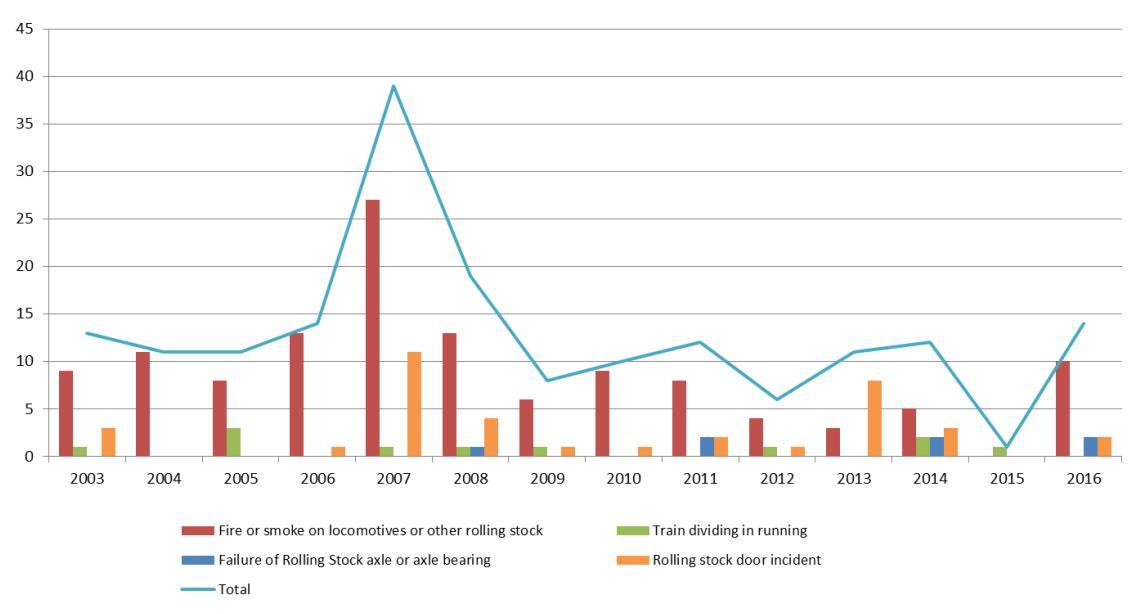
Figure 18 - Rolling Stock Incidents by year

Failures with rolling stock have the potential to be catastrophic. The number of reported occurrences remained very low in 2016 with the exception of fire/smoke occurrences. The majority of engine fires in 2016 occurred to either the 22000 or 29000 fleet. Every occurrence was investigated by IÉ, with no obvious trend identified. In all cases actions were taken to have to reduce the chance of reoccurrence including fleet-wide checks when considered necessary.

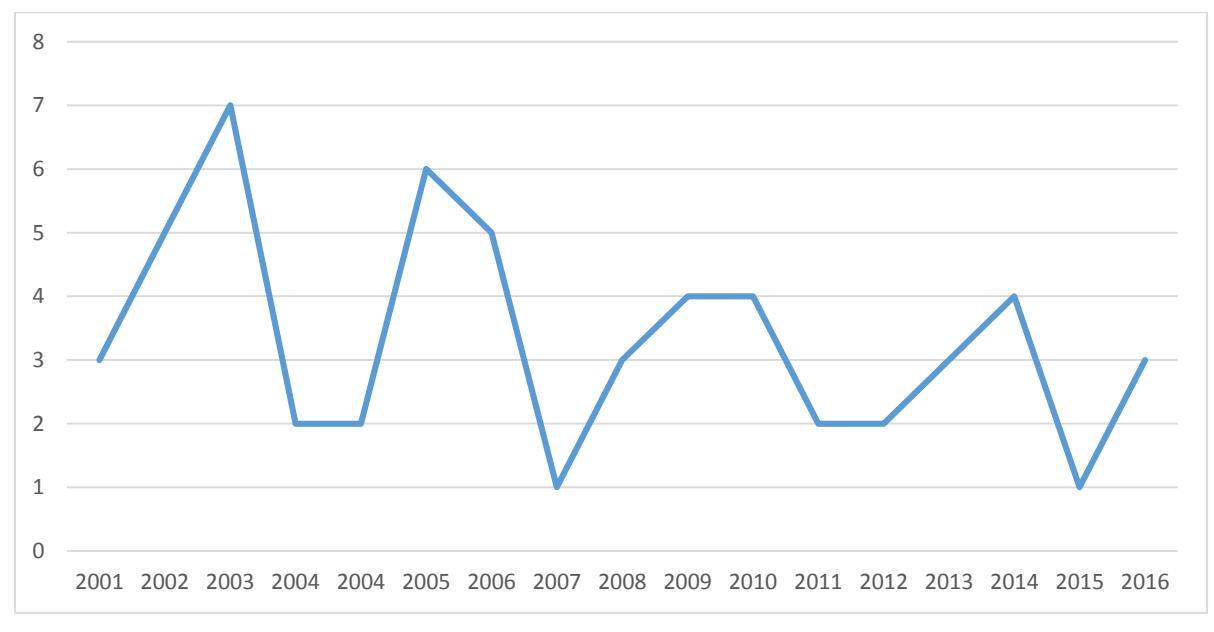
Figure 19 - Broken Rails by year

Iarnród Éireann visually inspects the track at least once per week and rails are ultrasonically tested at least every 2 years, with the vast majority tested annually. There were three broken rails on a passenger carrying line in 2016 in line with a trend established since 2001, see Figure 19 - Broken Rails by year. Whilst these did not result in a train accident, it is an area where IÉ remains vigilant. The CRR closely monitors Iarnród Éireann's management of its assets through regular supervision meetings.

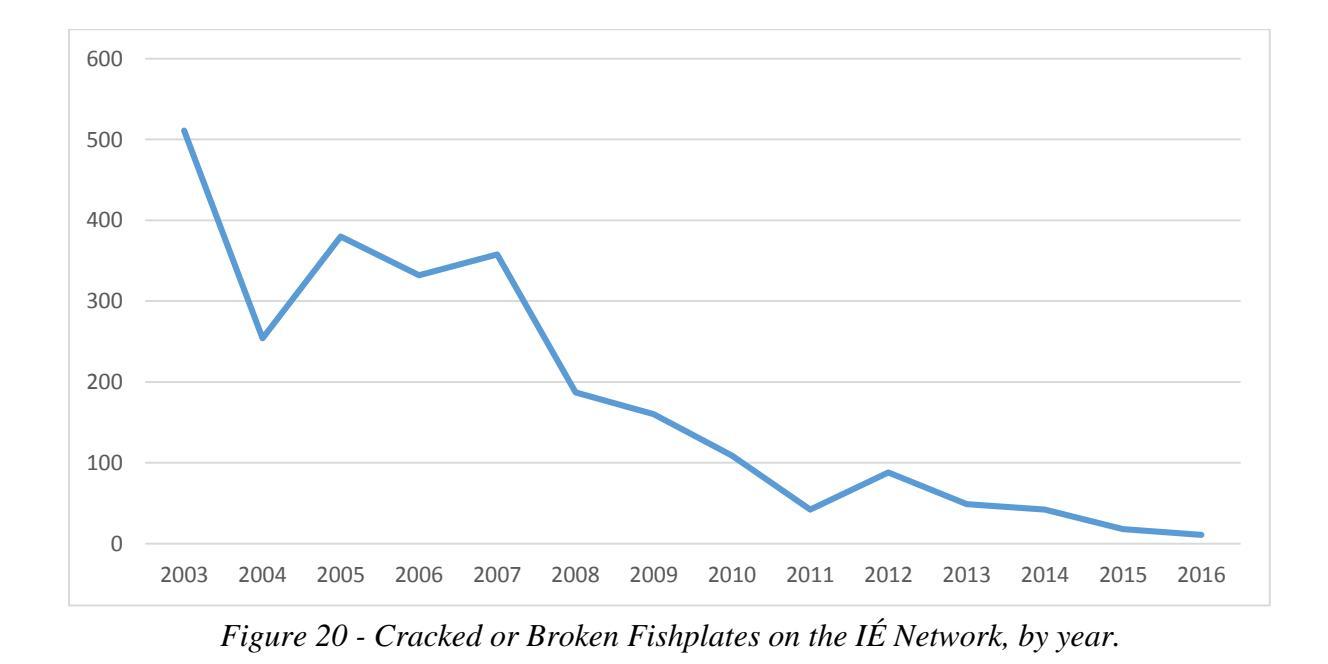
A fishplate is a special bolted connection that joins two rails together. The trend for 'Cracked' or 'Broken Fishplates' continues on the overall downward direction seen over the last ten years. Following a small rise in 2012, a significant decrease was noted for 2013, with this trend continuing in 2014, 2015 and 2016. This decrease is attributable to the installation of continuous welded rail (CWR) under the Railway Safety Investment programme (1998-2013).

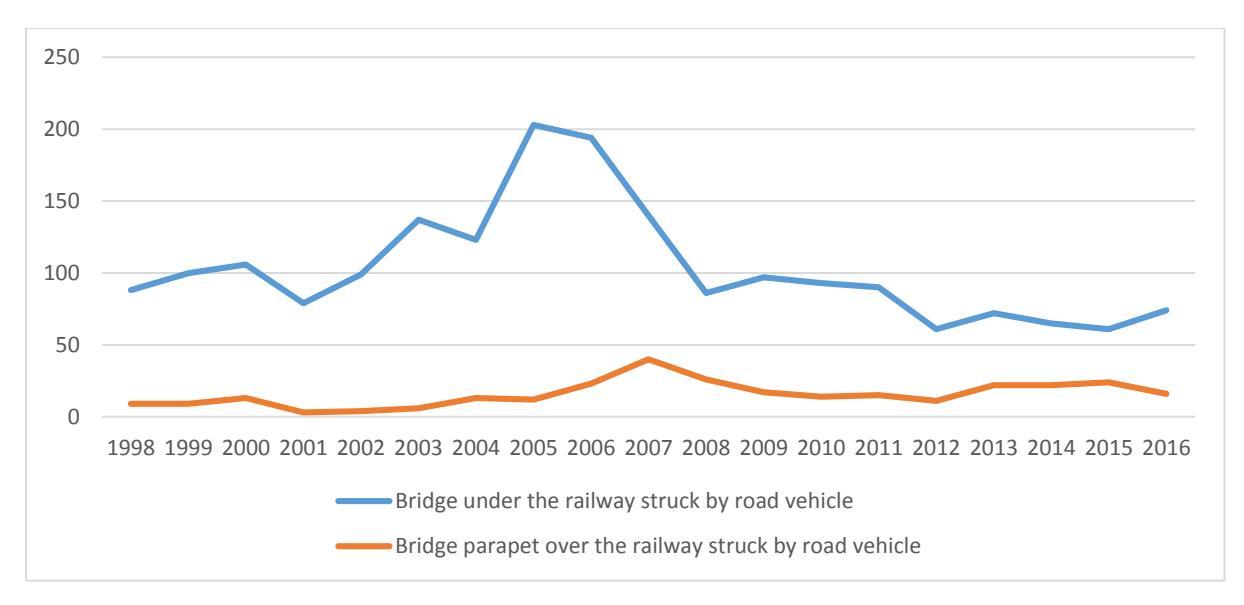
Figure 21 - Railway Bridges struck by road vehicles

A railway bridge may be a road over the railway or it may carry the railway over a road. A bridge strike is therefore where a road vehicle strikes the parapet or roadside containment of a bridge over the railway or where a road vehicle strikes the underside of a railway bridge over a road. Both types of incident can, in certain circumstances, result in very severe consequences and road users should be mindful of their driving in the vicinity of the railway. If driving an oversized vehicle, road vehicle drivers should know their vehicle height.

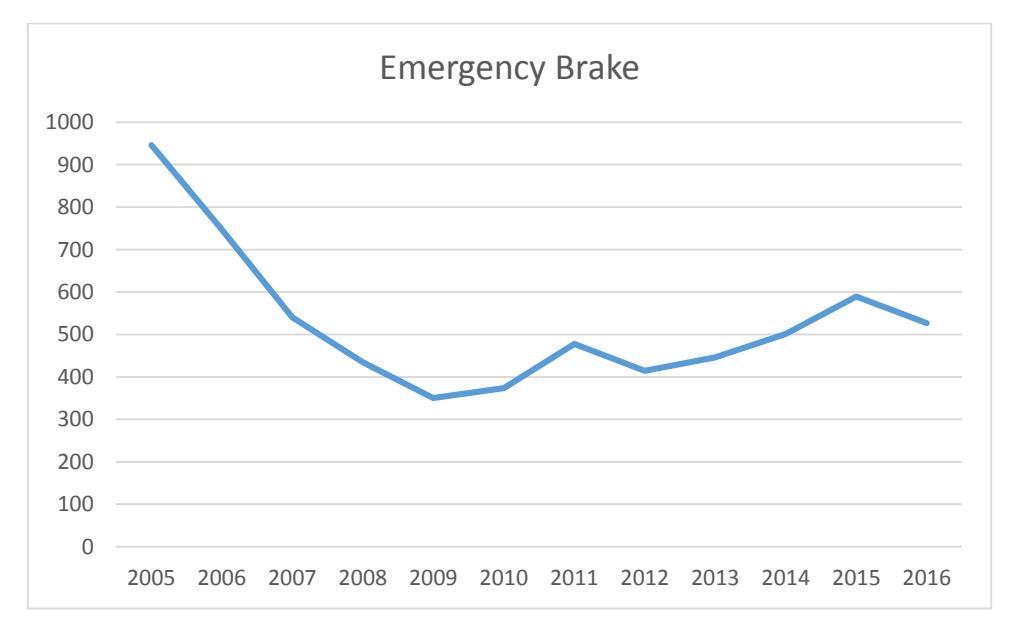
Figure 26 - Emergency Brake Applications

A useful precursor indicator is the number of Emergency Brake (EB) applications which tram drivers make. In addition to its standard brakes, a tram is fitted with an electromagnetic track brake. There are occasions when a driver may need to apply the EB to prevent a harmful incident.

There were 527 EB applications made in 2016 representing about an 11% decrease on 2015 figures. Operator analysis of this long term trend since 2009 indicates EB applications are linked to new or changed items on the system such as new drivers, new infrastructure, or modifications to tram signalling systems. Trandev have been running training and coaching of drivers in defensive driving to reduce the need for EBs which whilst avoiding a contact with pedestrian or other road vehicle, may cause an incident for a passenger on board due to sudden braking and associated jerk forces. The operator is striving for the goal of the optimum to allow the safe and effective operation of the system.

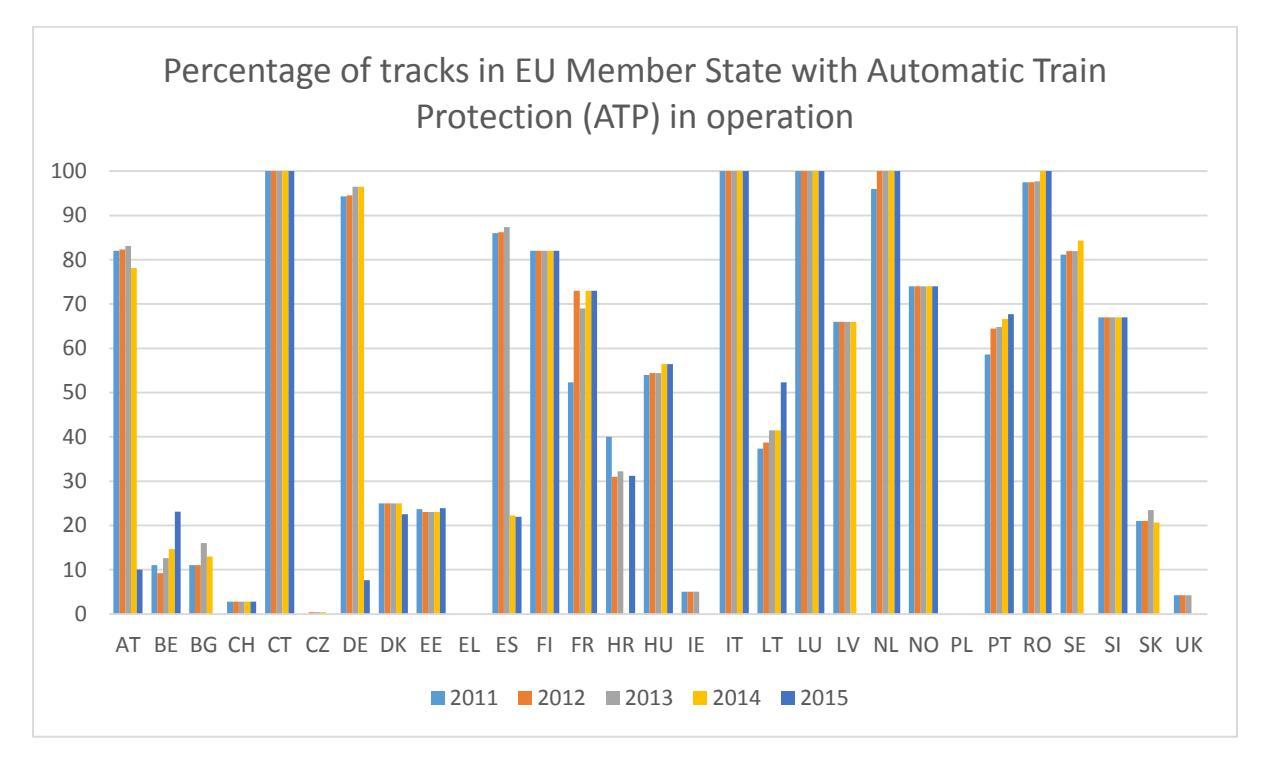
Figure 27 - Percentage of EU/EEA tracks with Automatic Train Protection (ATP) in operation, by country

warns the driver of the signal aspect ahead. It also requires the driver to acknowledge a signal downgrade, so as to avoid a penalty brake application.
