> Railway Safety Performance in Ireland 2018

The Commission for Railway Regulation is pleased to publish its Annual Safety Performance Report for 2018. This report supplements the CRR's Annual Report to the Minister and provides further detail on the safety performance of the railway organisations operating in Ireland.

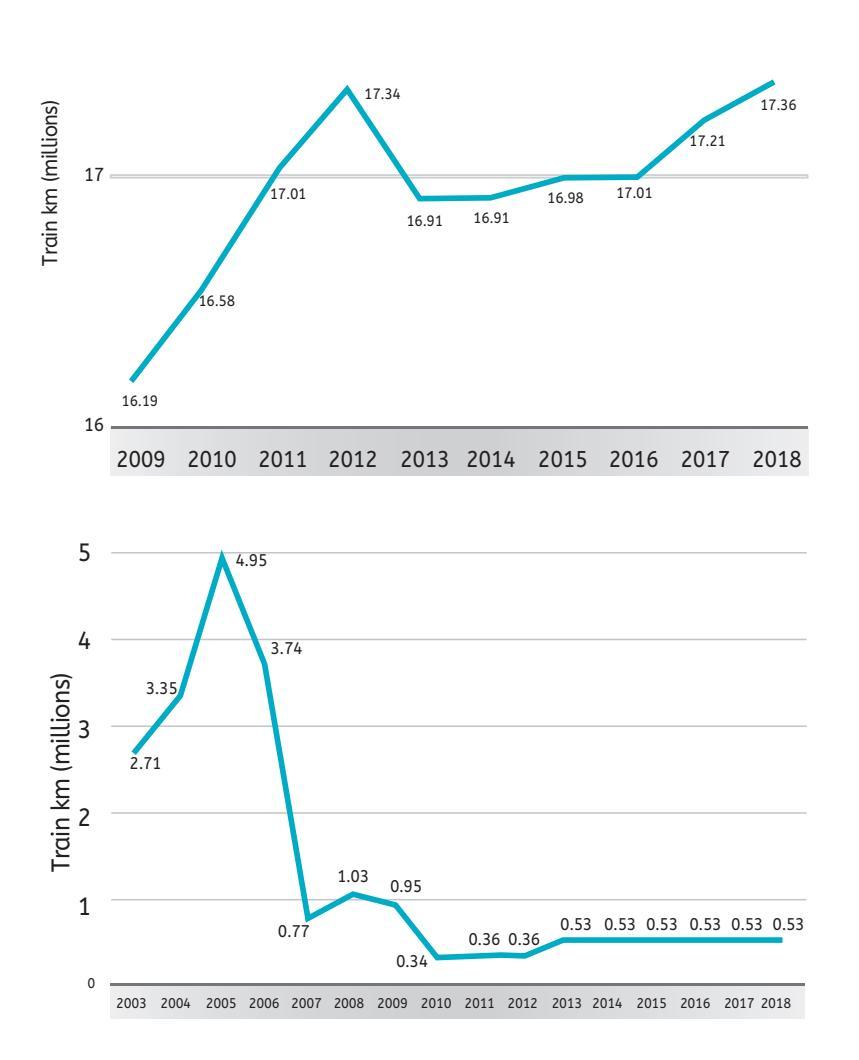
Figure 2: Passenger Train-km (top) Freight Train-km (bottom) on the IÉ-IM Network

Figure 2 shows that although the passenger journeys have increased, overall train km were slightly reduced in 2018. However, IÉ-RU passenger train kilometres increased by approximately 1% so the reduction in train kilometres comes from other operators (e.g. BBRI, RPSI, IÉ-IM engineering trains). The difference between passenger journey growth (5%) and passenger train kilometres (1%) suggests that trains are operating nearer capacity, which further suggests a more efficient use of rolling stock. The CRR is aware that the fleet is fully deployed and there are no additional carriages available at this time to increase capacity at present.

Freight kilometres have remained stable since 2013 and continue at the same level in 2018.

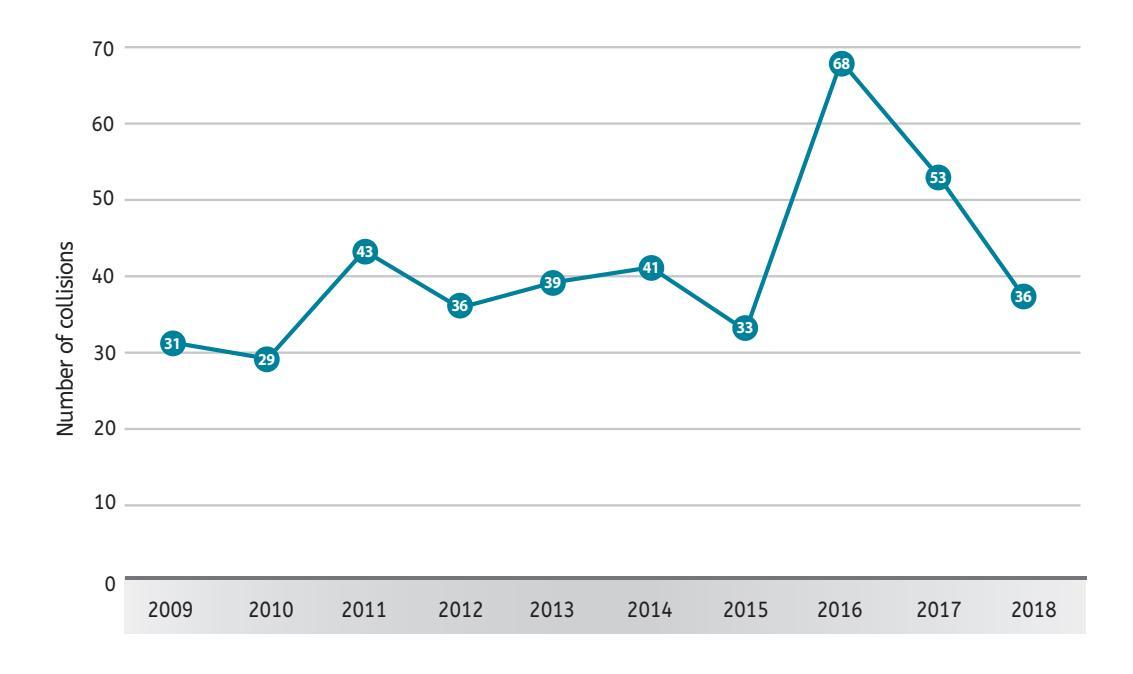
Figure 8: Total Collisions by year

Figure 8 is supported by Table 2 and Figure 9 to aid understanding of the data. In figure 9 two categories, 'Total Collisions with Obstacles on the line' and 'Train Collisions with large animals', have been separated to enhance visibility of the data as in isolation is of limited benefit. The overall data shows a continued decrease in collisions in 2018.

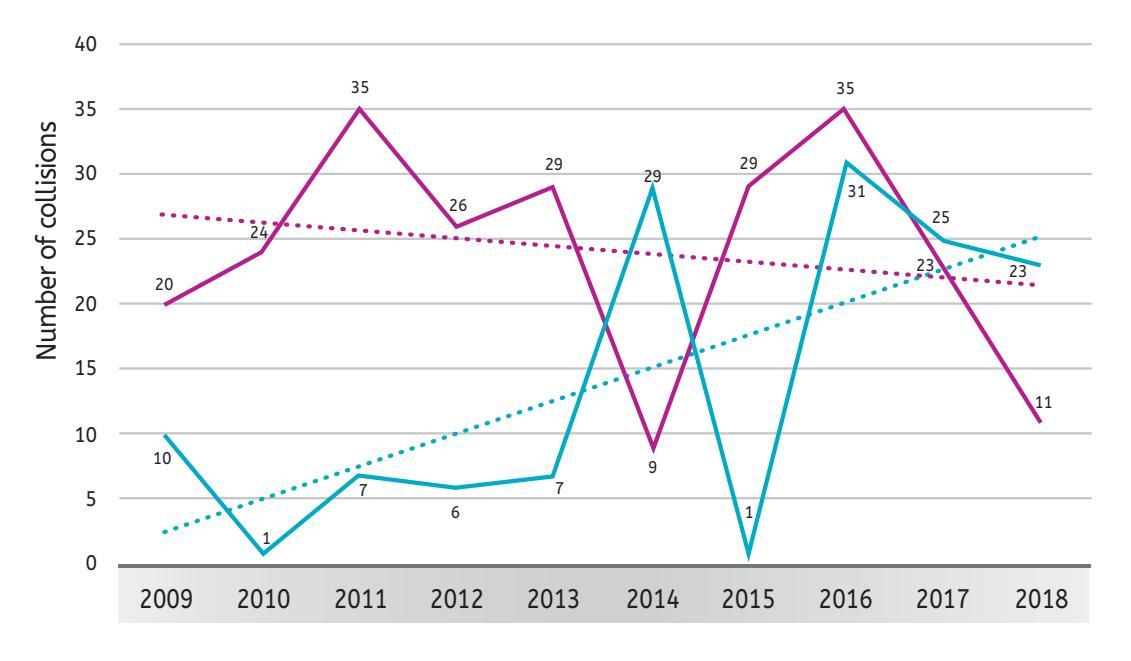
Figure 9: Train Collision Statistics detail by year, part 2

Table 2 shows that the 'train collision with other obstacle on the line' category was broadly in line with 2017. 2018 saw a continued decline in the number of collisions with large animals since the high of 2016. All other categories of collision either fell or remained static in 2018.

There has been some volatility in the data between 2013 and 2018, but since 2016 the trends are moving in a positive direction, i.e. collisions have been reducing. As discussed in previous reports, animals, (deer, cattle and sheep) are a major contributor to collision statistics in Ireland, but these types of collision fell in 2018. It is noted that larnród Éireann investment in fencing systems to protect against incursions to its railway during this period has possibly had the desired effect. In addition, the reduction in the number of level crossings over the last decade should also assist this trend.

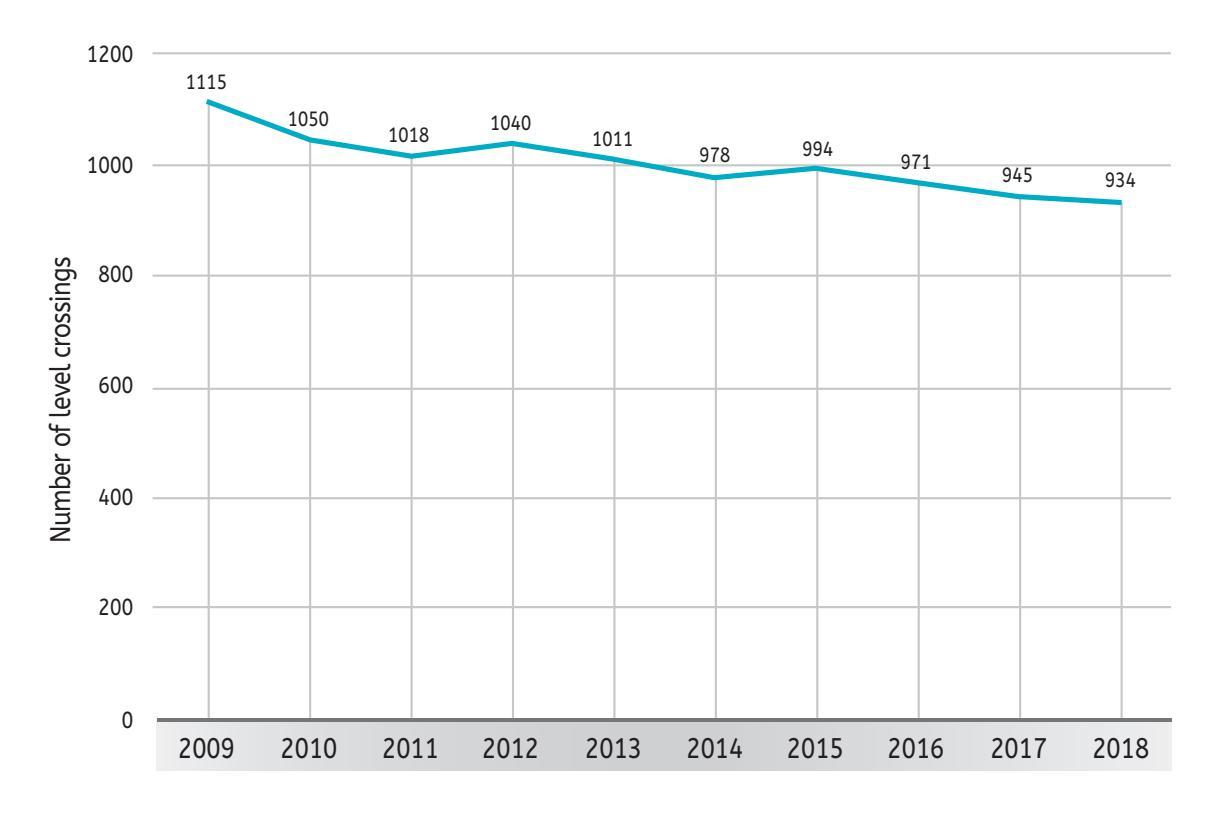
Figure 10: Number of level crossings by year

Figure 10 illustrates the number of level crossings on active lines. Sustained efforts by larnród Éireann have contributed greatly to reducing the risk presented by level crossings.

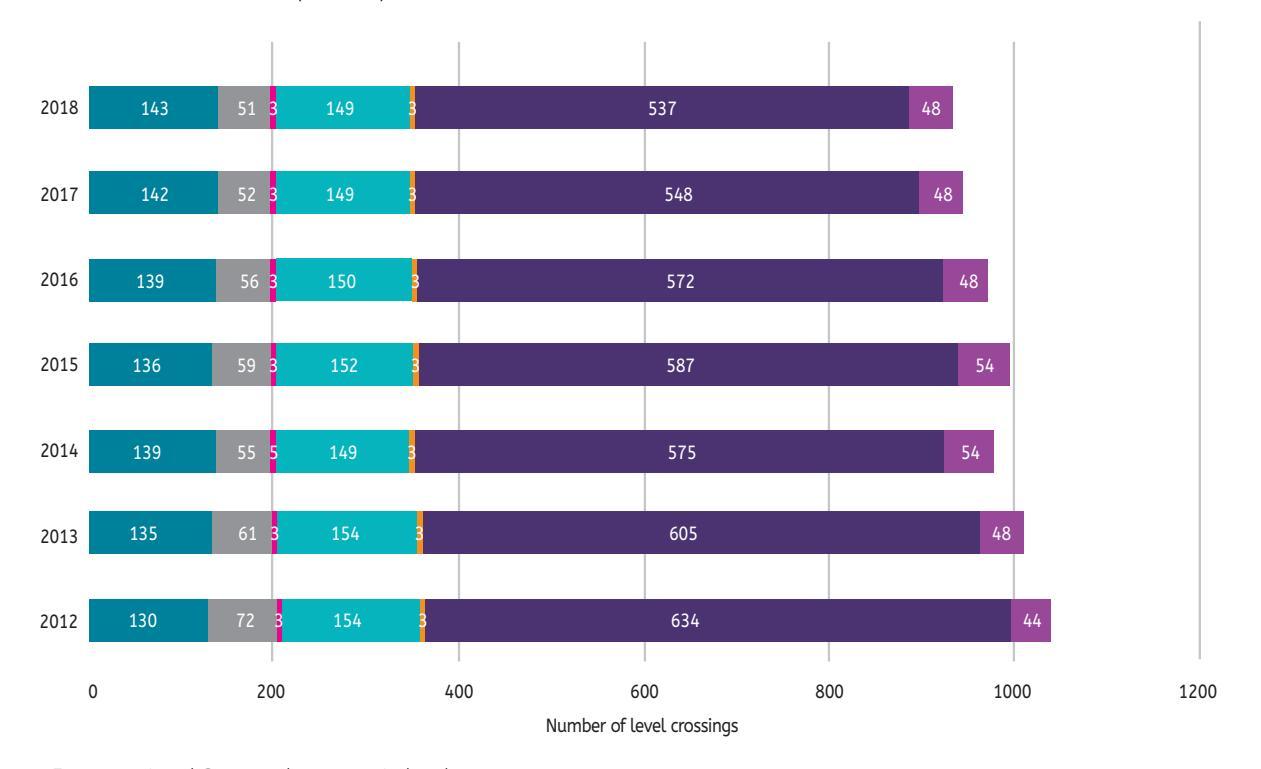
Figure 11: Level Crossing by type in Ireland

The breakdown of level crossings by type and year in Ireland is shown in Figure 11. Passive level crossings on public roads that require the road user to manually open and close gates remain the highest risk type of level crossing, closely followed by passive 'Field type' level crossings which are those a farmer might use if they have land on both sides of a railway. A fewer number of level crossing were closed in 2018 compared to the two previous years, nonetheless the overall figure is reducing which is welcomed. larnród Éireann are currently reviewing novel technological designs to enhance safety and operation at user-worked level crossings whilst operating within constrained budgets.

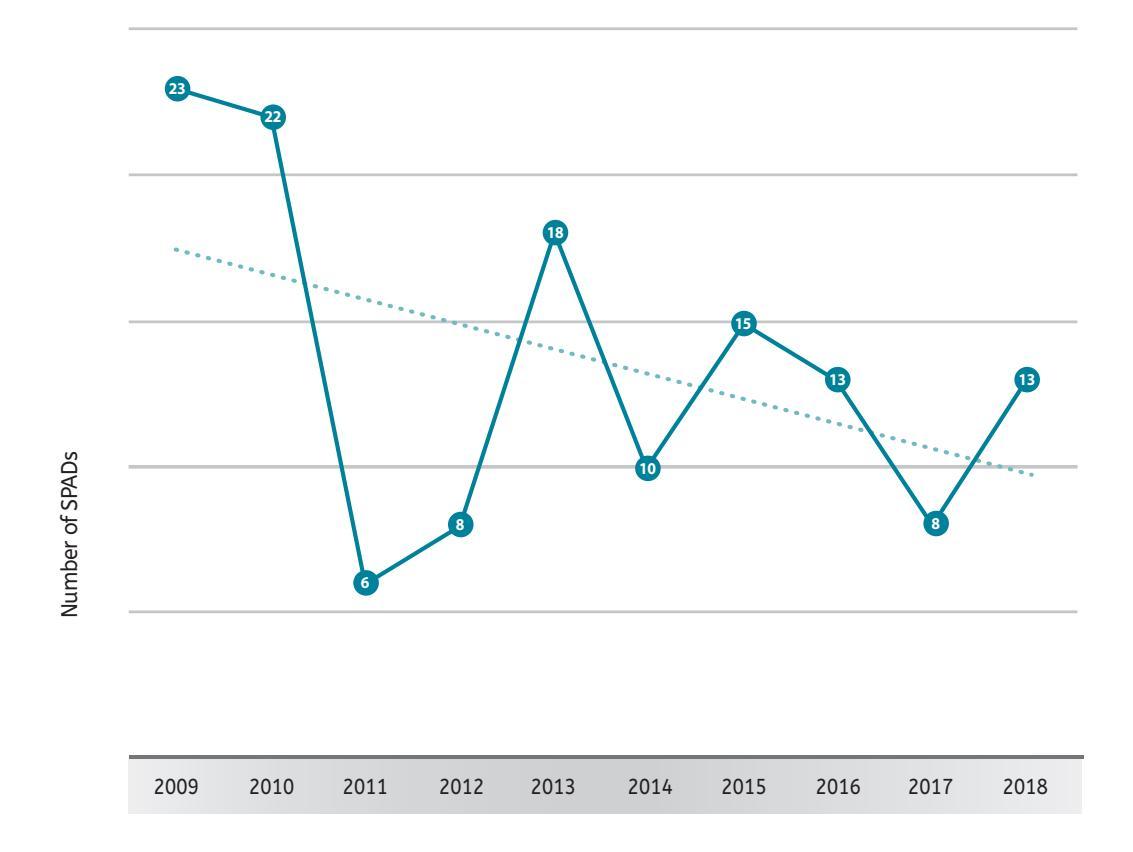
Figure 12: IÉ SPADs by year

A SPAD is defined as having occurred when a train passes a stop (red) signal without authority. SPADs are a particular precursor event that the CRR monitors regularly during its supervisory meetings with IÉ-IM and IÉ-RU. The trend in recent years has been a steady decline; although data for 2018 was higher than the previous year it was still in line with the low trend of recent years (Figure 12).

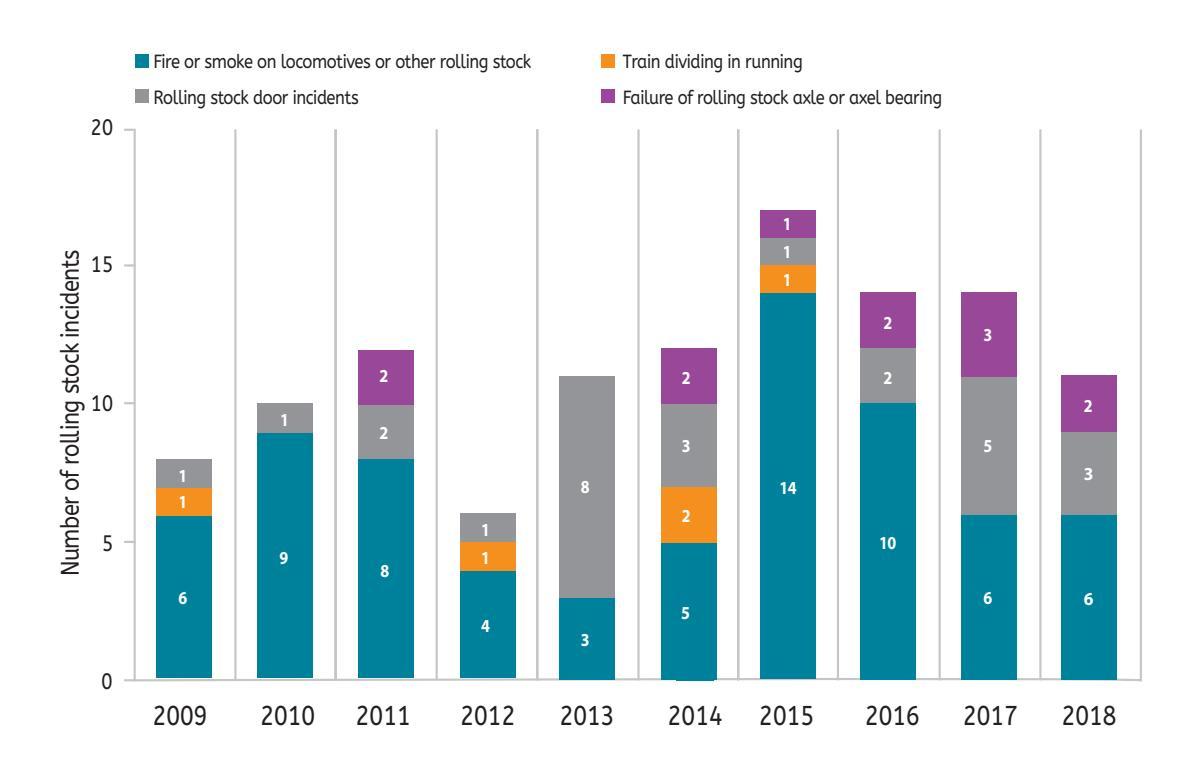
Figure 14: Rolling Stock Incidents by year

Failures with rolling stock can potentially have very serious consequences. The number of reported occurrences remained low in 2018 and all categories either fell slightly or remained level with 2017.

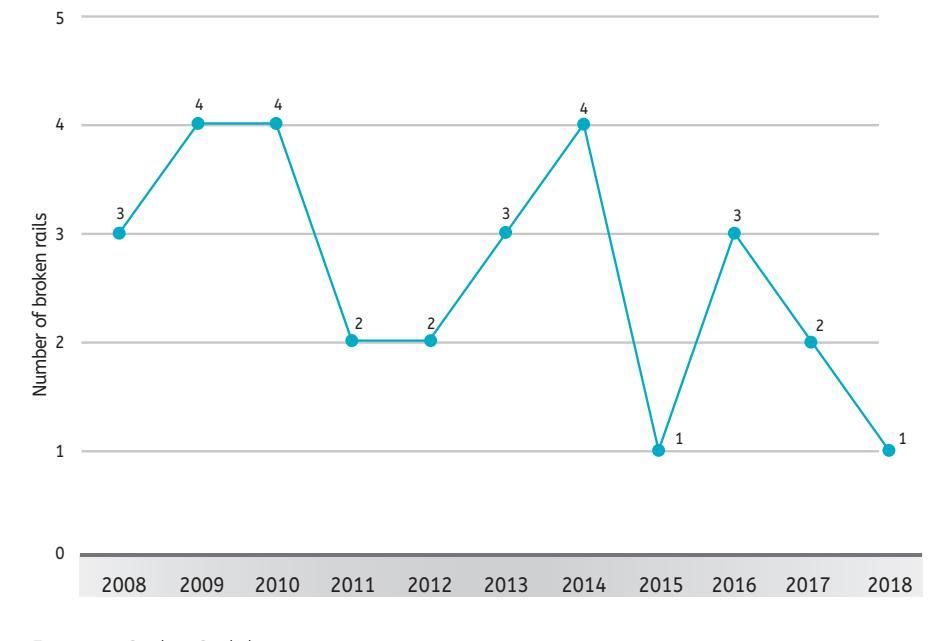
Figure 15: Broken Rails by year

IÉ-IM personnel visually inspect the track and associated assets at least once per week. Engineers and Infrastructure Managers also inspect the track a number of times each year using a dedicated Inspection Car. The rails themselves are ultrasonically tested at least every 2 years, with the vast majority tested annually. In 2018, there was just one broken rail on a passenger carrying line which is consistent with the low numbers of recent years (Figure 15). Whilst this did not result in a train accident, it is an area where IÉ-IM remains vigilant. The CRR, through its regular supervision meetings monitor larnród Éireann's management of its assets as well as through our inspections and audits.

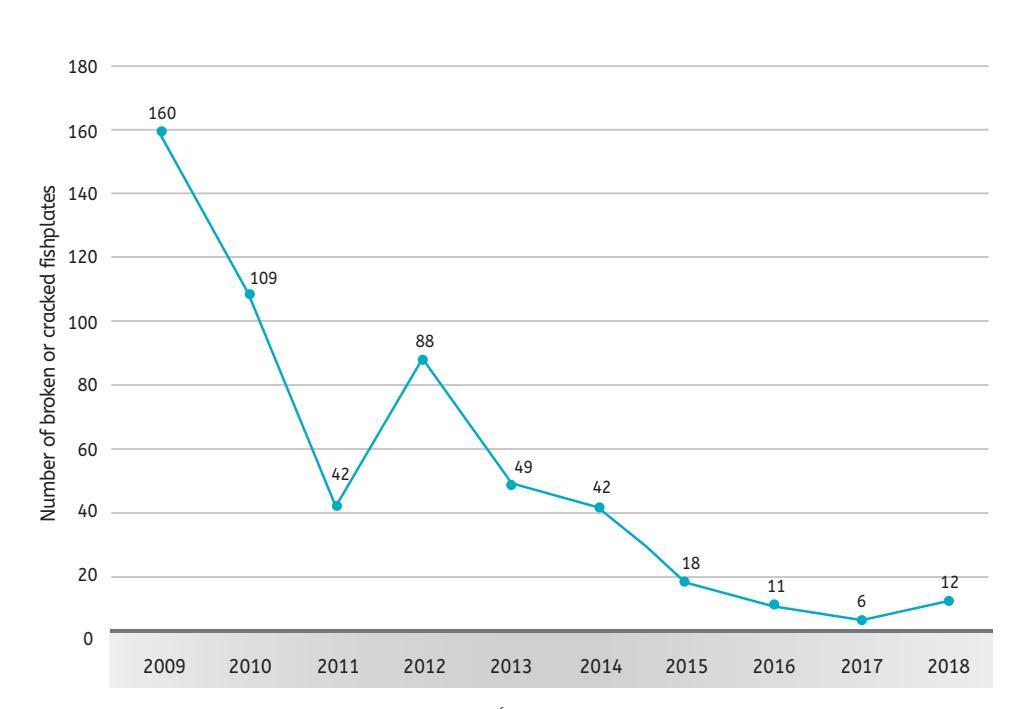
Figure 16: Cracked or Broken Fishplates on the IÉ Network, by year.

A fishplate is a special bolted connection that joins two rails together. Should one break then the rail is not continuous and could, in certain circumstances, lead to a derailment. The trend for 'Cracked or Broken Fishplates' has increased slightly in 2018, breaking the continuous overall downward direction seen since 2012 (Figure 16). The large decrease over the 10-year period may be attributed to the installation of continuous welded rail (CWR) initiated under the Railway Safety Investment Programme (1998-2013) and continued since.

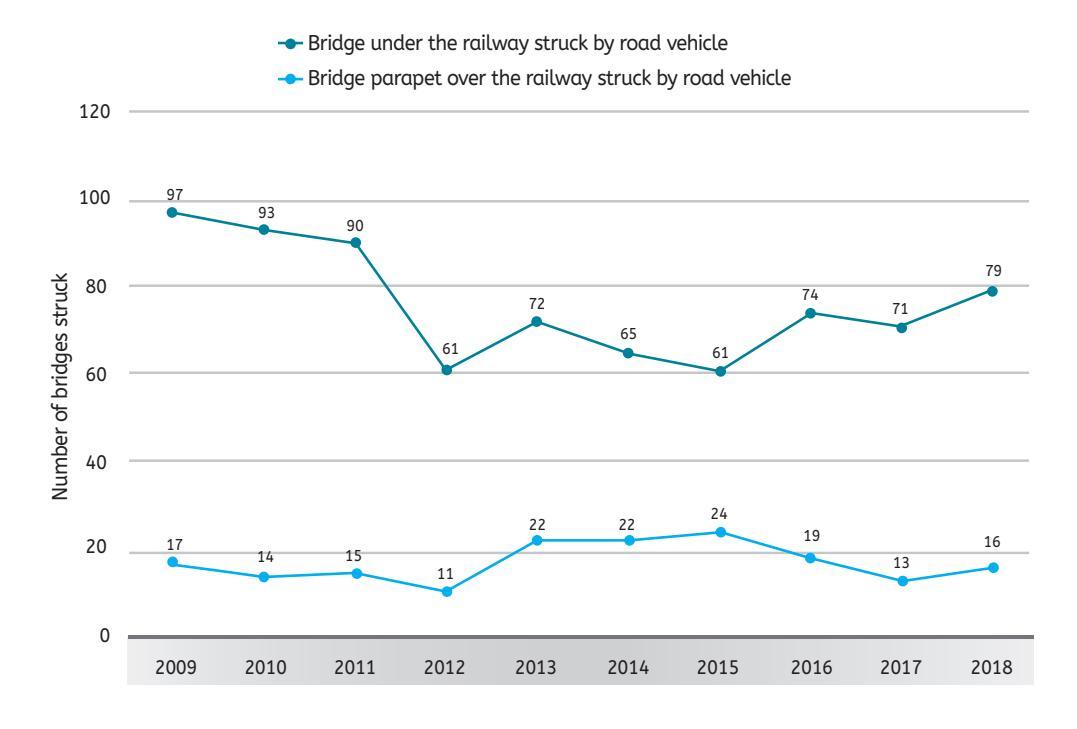
Figure 17: Railway Bridges struck by road vehicles

The total number of bridge strikes, i.e., both underbridge and over-bridge, rose in 2018 compared to 2017 (95 vs. 84 in 2017) with the majority being under-bridge strikes (Figure 17). Overall, the trend for both underand over- bridge strikes has remained relatively stable since 2009.

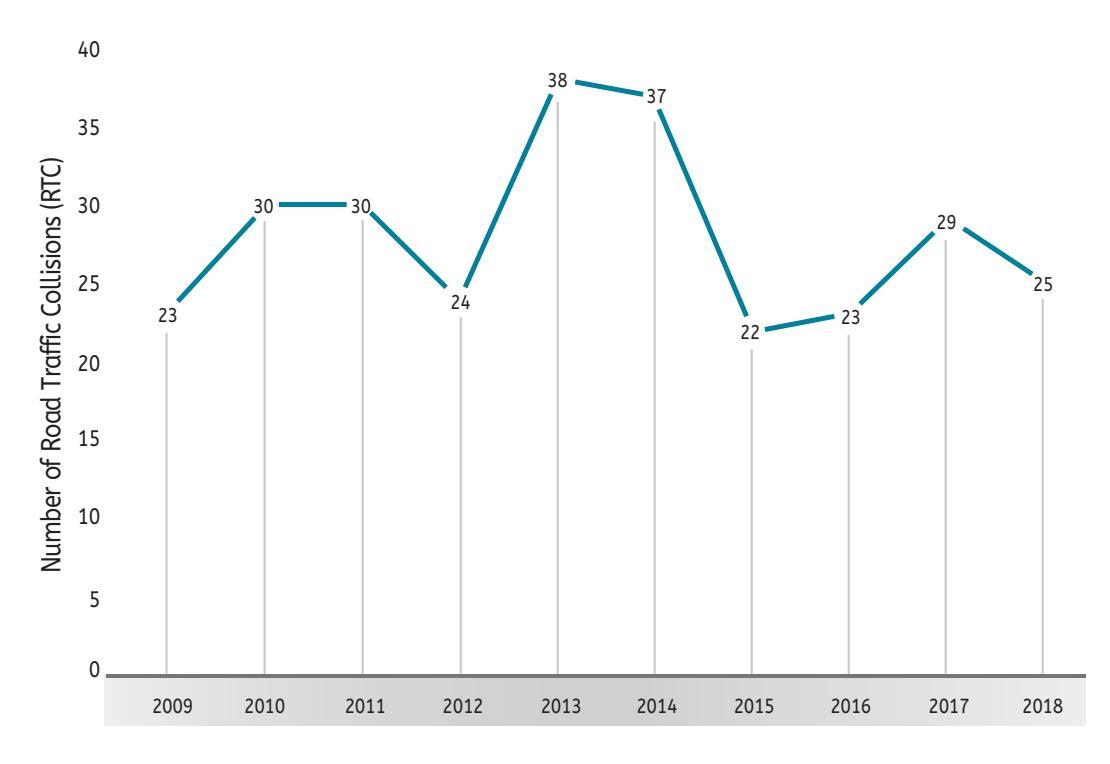
Figure 19: Number of Road Traffic Collisions involving a tram

The number of road traffic collisions has decreased slightly to 25 in 2018 from 29 in 2017 (Figure 19). The decrease was entirely on the Red line, where RTC decreased from 23 in 2017 to 17 in 2018. RTC on the Green Line increased by two to eight, with all but three

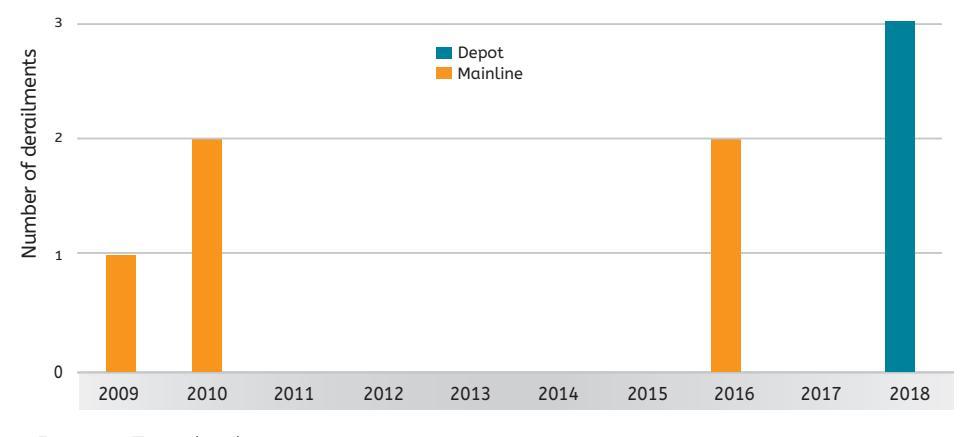
Figure 22: Tram derailments

There were three derailments in 2018 (Figure 22). This increase is noted and the highest level in the last 10 years. However, all three derailments were in maintenance facilities, 1 in Sandyford Depot and 2 in the Red Cow Depot. The derailment in Sandyford was attributable to human error while the two derailments in the Red Cow, both of which happened on the same day were attributed to inclement weather. There had been persistent snow fall and the packing of the snow in the points mechanisms prevented them from moving, resulting in the derailments.

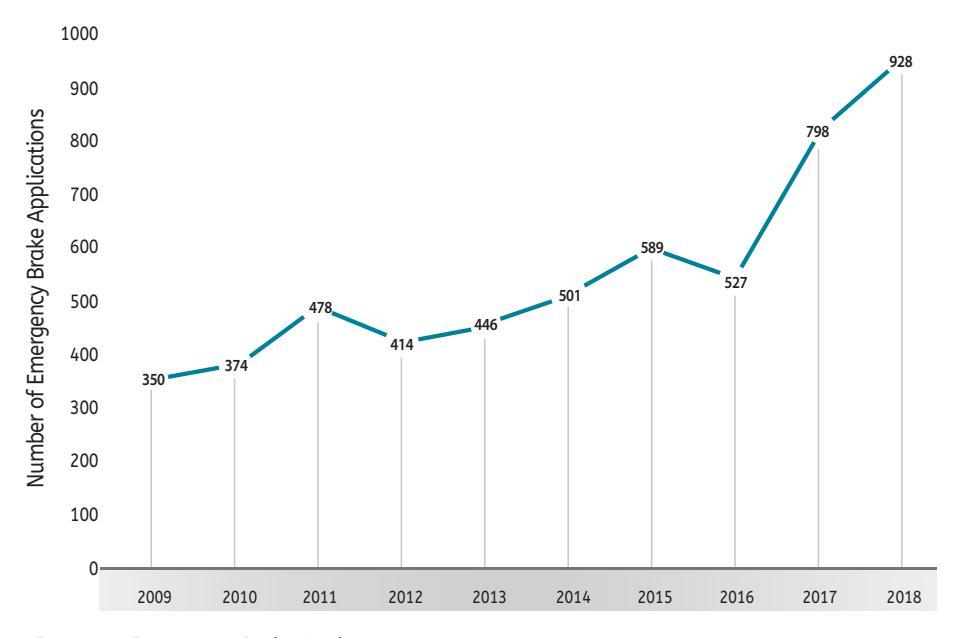
Figure 23: Emergency Brake Applications

There were 928 EB applications in 2018 representing a 16% increase on 2017 figure and the highest figure in the last 10 years (Figure 23). The CRR investigated whether the rise in EB applications in 2017 was due to the intake of a new cohort of drivers during that year, but this could not be proven. It is noted, however, that the number of tram kilometres run has increased, but there is still an increase in EB applications when normalised against this.

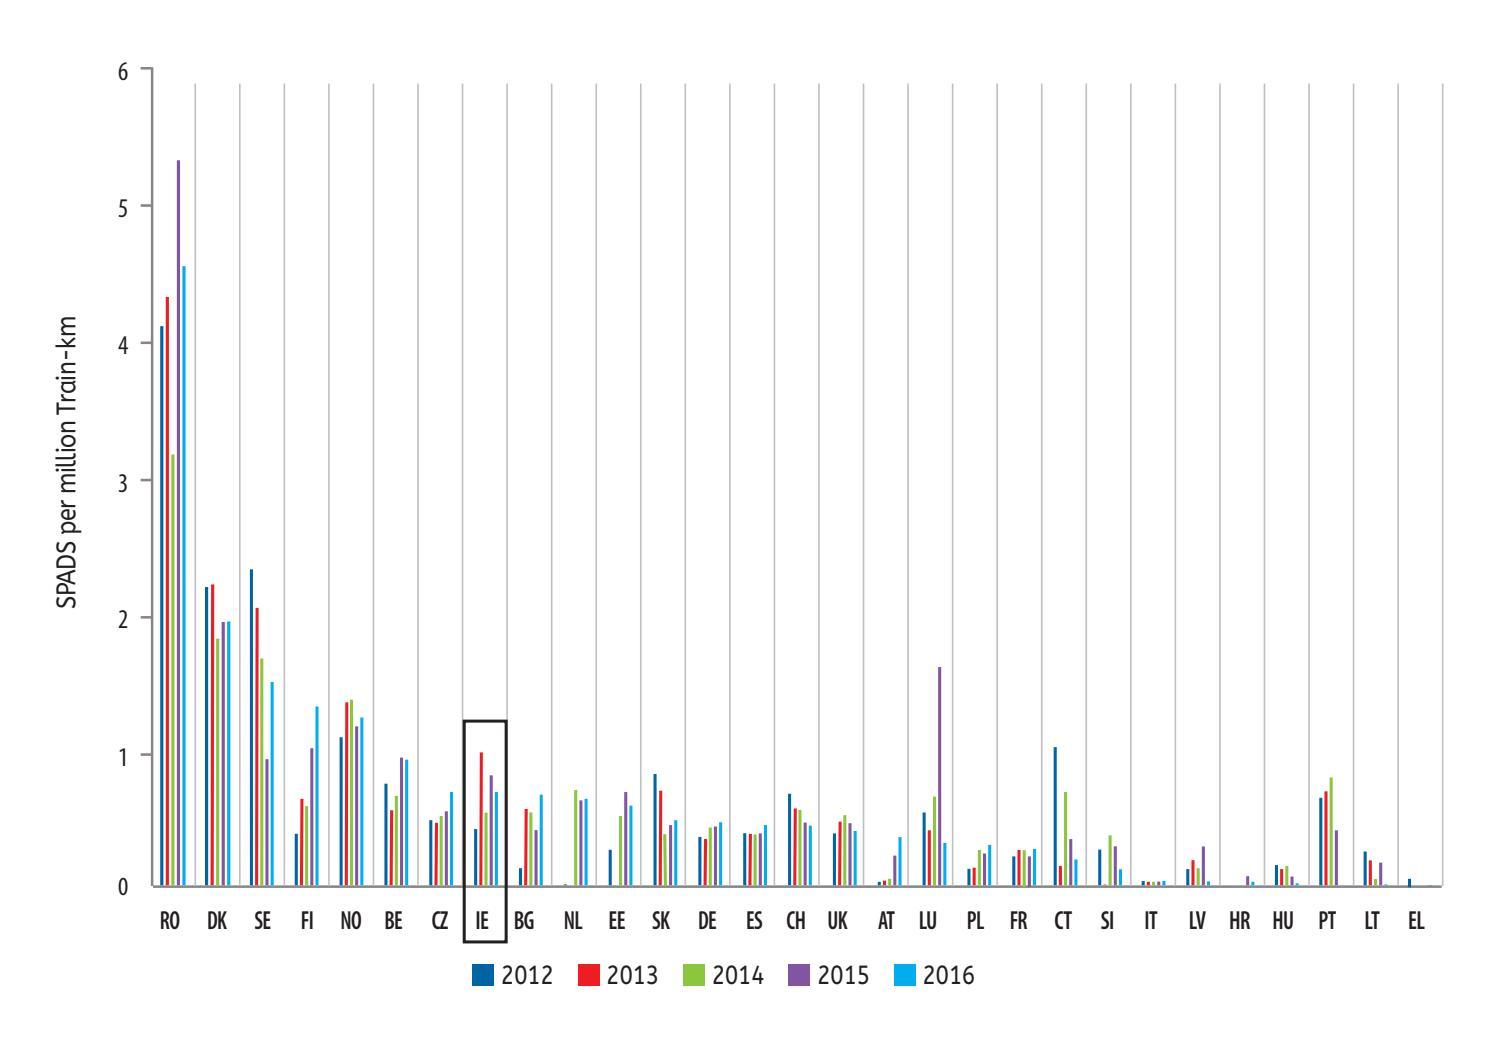
Figure 30: Signals passed at danger per million train-km

The data improved in 2016 and again in 2017 but as discussed earlier in this report, the 2018 SPAD rate worsened somewhat. Only a small number of SPADs were categorised as serious, nonetheless there are still improvements to be made in this area.

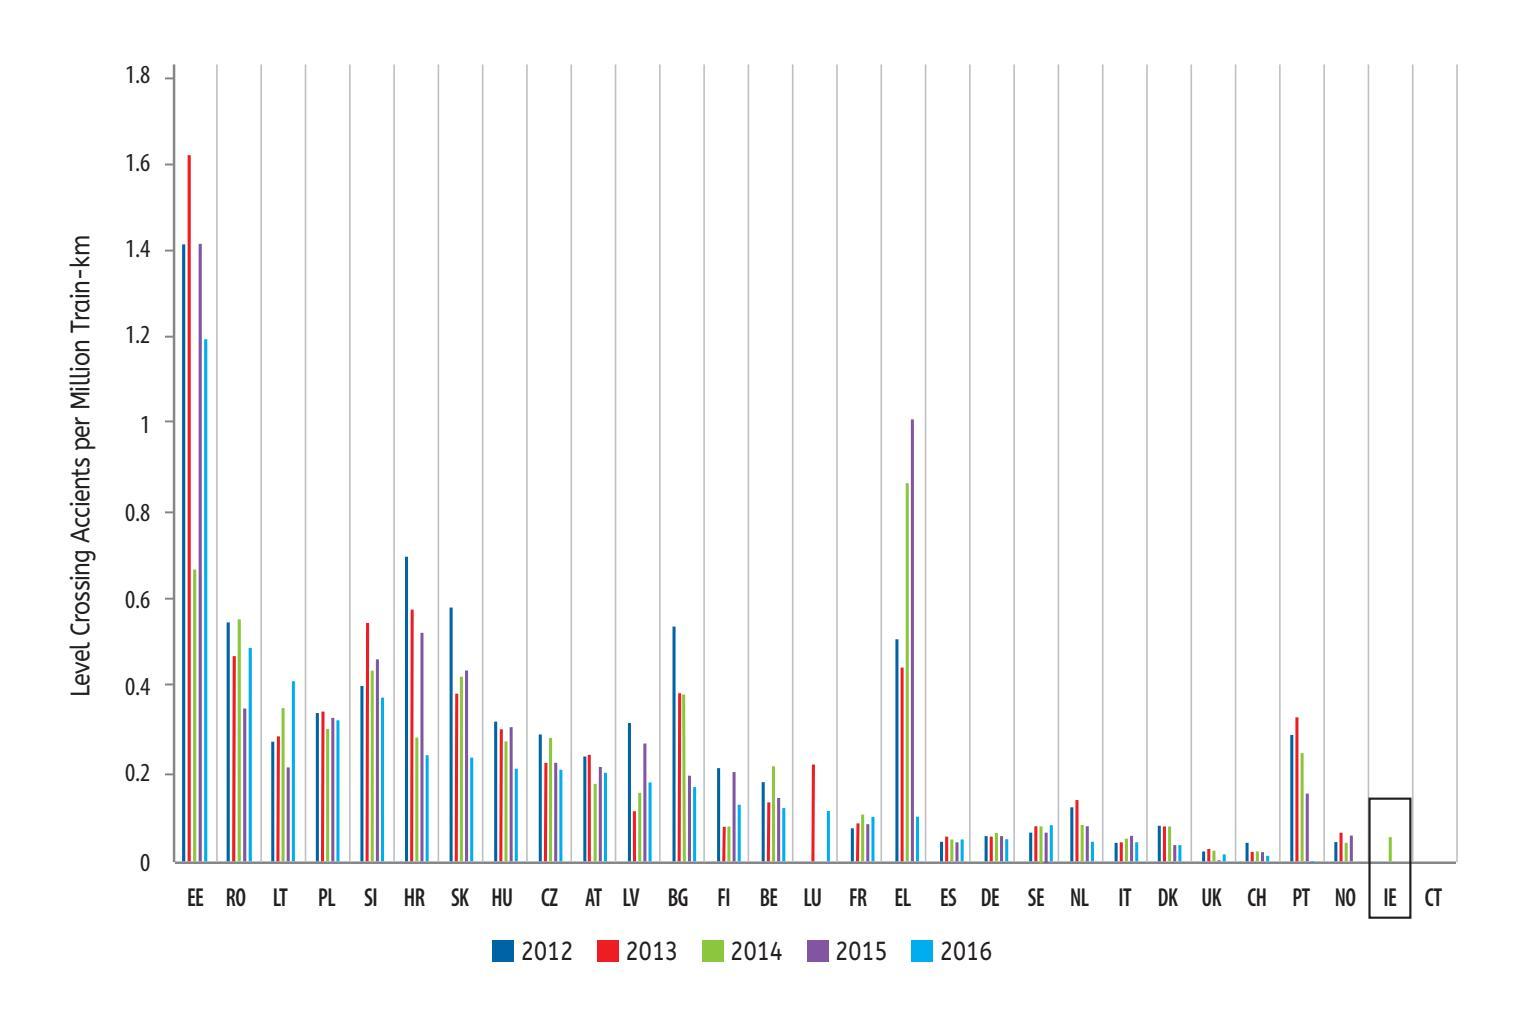
Figure 31: Level crossing accidents relative to train km

Level Crossings are a significant risk to railway safety and the density of level crossing on the Irish network is above the EU average. However, it is clear from the data presented in Figure 31 that Ireland, in comparison to other European countries, has a positive safety record in terms of level crossing accidents relative to train kilometres.

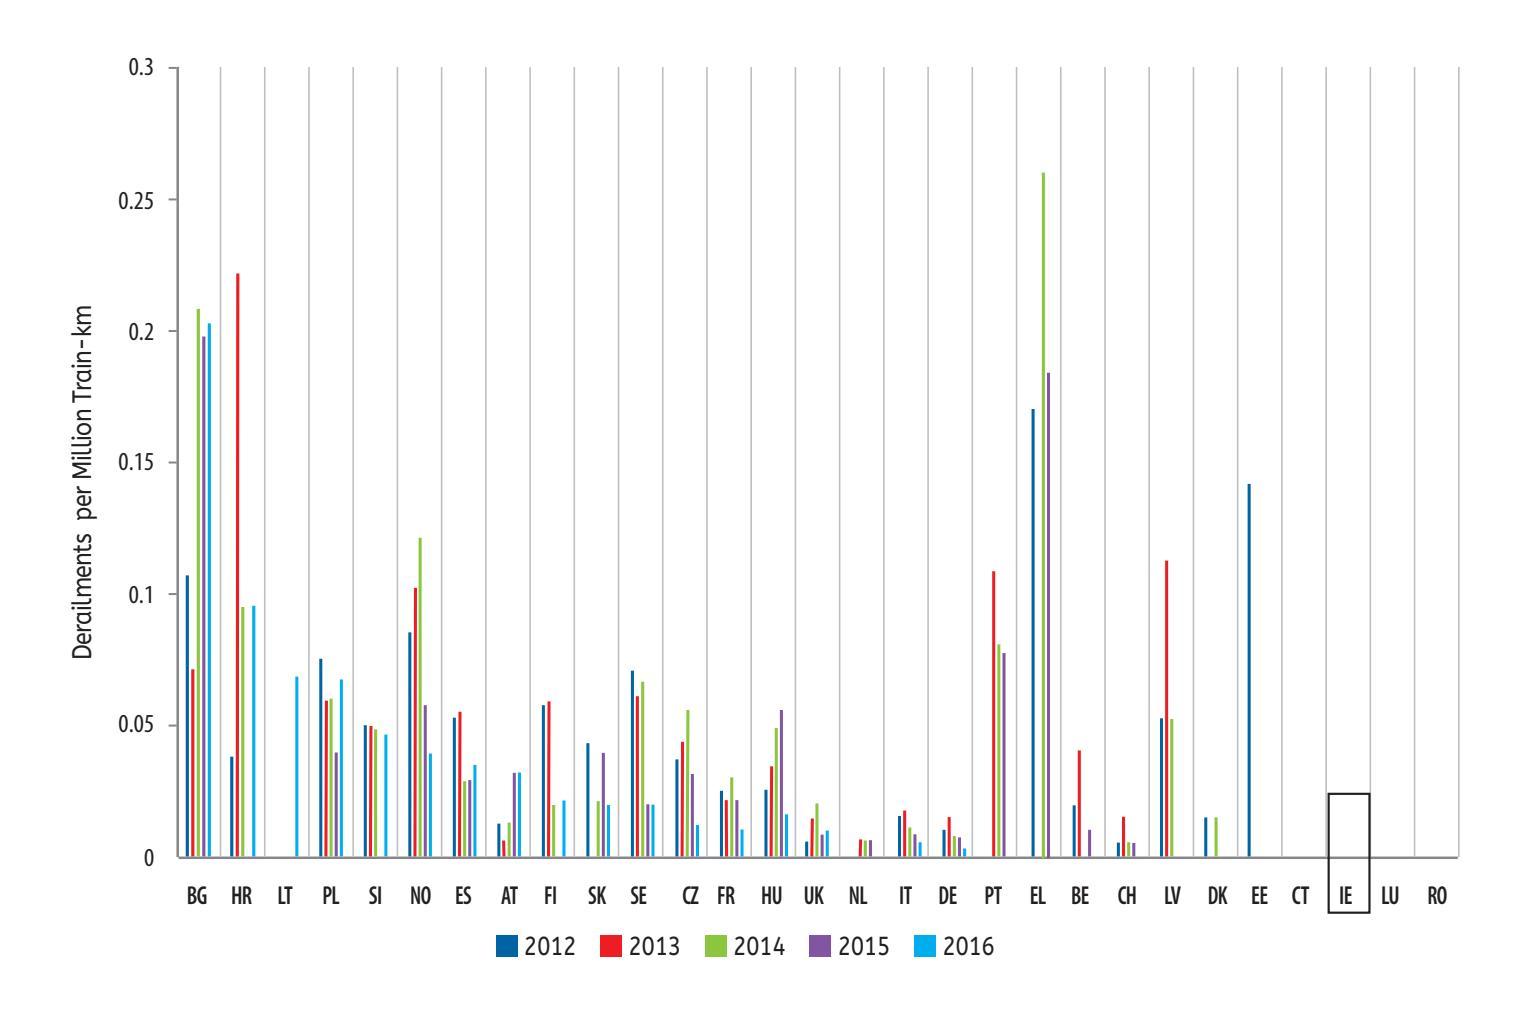
Figure 32: Derailments of trains relative to train km

Ireland has had no passenger derailments in the period 2012-2016, and so has one of the lowest rates across Member States (Figure 32). Whilst the Irish Network is relatively low speed and has low utilisation compared to some other member states, derailment risk still requires careful management in a challenging environment where resources have been reduced in the period under review.

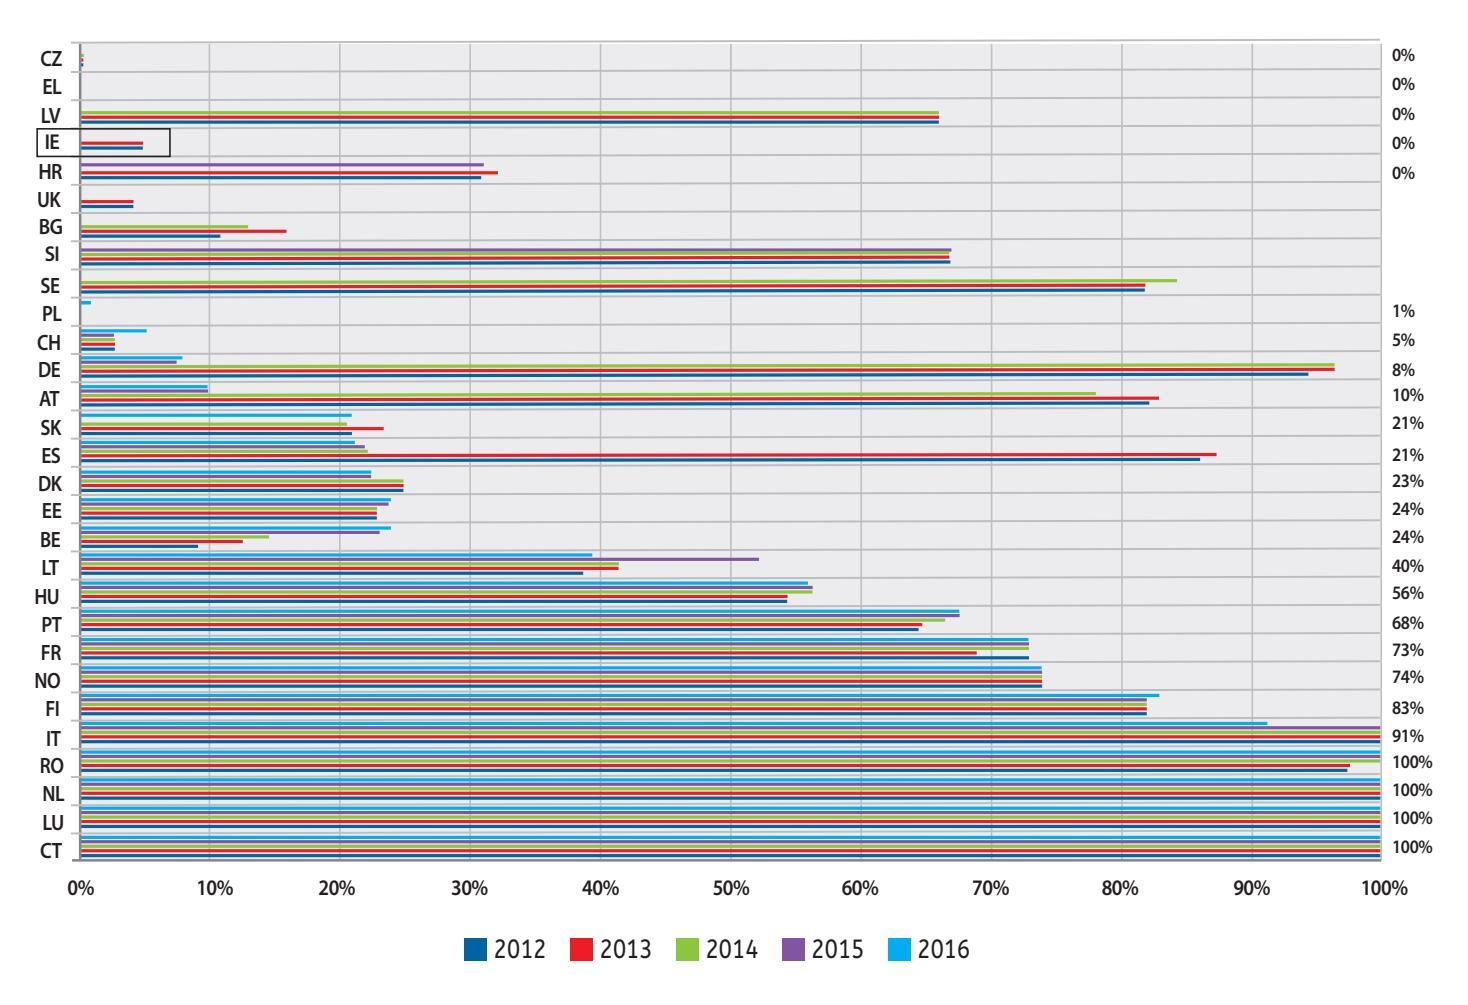
Figure 33: Percentage of EU/EEA tracks with Automatic Train Protection (ATP) in operations, by country (2012-2016)

One leading indicator of railway infrastructure safety is the percentage of railway fitted with Automatic Train Protection (ATP). ERA, in common with most professional railway organisations, considers ATP to be the most effective railway safety measure that railway infrastructure managers can implement to reduce the risk of collisions and derailment on mainline railways. ATP enforces obedience to signals and speed restrictions by speed supervision, including automatic stopping at signals. 25 Member States reported the percentage of lines equipped with such a system. This data over the period 2012-2016 is shown in Figure 33, with the most recent figure (2016) shown at the end of each bar.
