Railway Safety Statistical Report 2009

June 2010

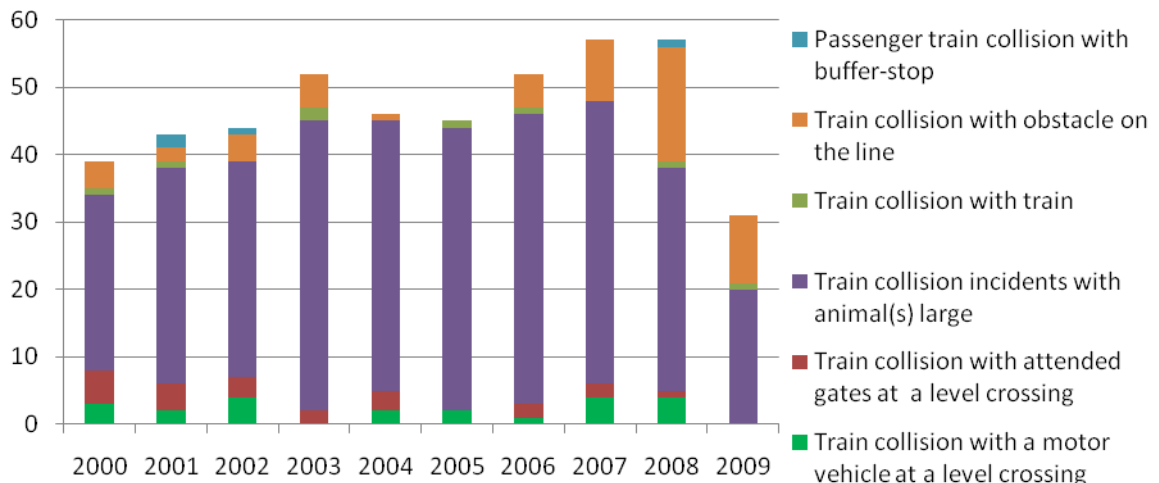
Graph 4: Train Collision Statistics by year

Train collisions can pose a significant risk to passengers, train crew and third parties (if applicable) and have the potential to cause considerable damage to rolling stock. IÉ's fleet is one of the newest in Europe and has been designed to international standards that provide an enhanced level of safety to passengers and train crew should a train be involved in a collision. Graph 4 illustrates the trend over the past 10 years.

Regarding collisions with obstacles on the line there were 10 such incidents in 2009. These were attributed to collisions with trees and branches, a maintenance trolley, steel objects such as bars and a super market trolley.

Collisions with animals can, in some instances, cause considerable damage to trains particularly large animals such as cattle or deer. In 2009 there were 20 such occurrences and, fortunately, none resulted in significant damage to trains. IÉ has invested significant resources in recent years upgrading the railway boundary and the benefit is now being realised with a decrease in animal strikes of circa 50% in the last 3 years.

Train collisions with other trains are infrequent and most often than not occur at low speed within stations. One such incident was reported for 2009, where a locomotive was in collision with a train during a shunting movement.

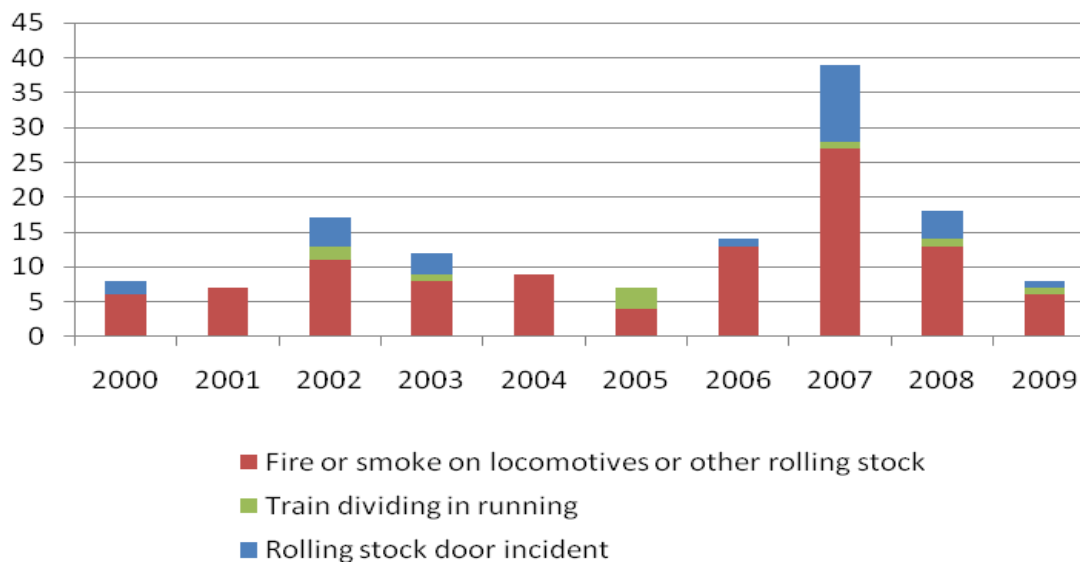
Graph 8: Rolling Stock Incidents

There has been a recent prevalence of fire or smoke incidents on diesel multiple unit trains, a number of which were due to engine component failures. Iarnród Éireann, the train manufacturers and their suppliers have been addressing this issue. In 2009 there were six 'fire and/or smoke' occurrences. All were of a minor nature with on board automatic fire suppression systems functioning as expected.

A train divide is an occurrence where a train splits into two. The split would occur between carriages. In 2009 there was one train divide. It occurred to a 22000 unit in Portlaoise. The 6 carriage train, made up of two, 3 carriage trains coupled together split as it crossed from one track to another. The train was not in service and there were no passengers on board. Both the Railway Accident Investigation Unit (RAIU) and IÉ commenced an investigation into the divide and the cause will be made known in due course.

In terms of door issues, from the peak in 2007 the rate of incidents has all but disappeared. Maintenance, reliability and other vigilance systems are ensuring door incidents are low. There was just one such incident in 2009 and this occurred when a broken spring on a door had necessitated that the door be locked off prior to the trains departure from Heuston. Whilst en route, the train host noted the locked off door and, not being aware of the reason, unlocked it whilst approaching Thurles. The door opened and the train host, on seeing this, reclosed the door.

Graph 8 (on next page) illustrates the trends for these statistics in recent years.

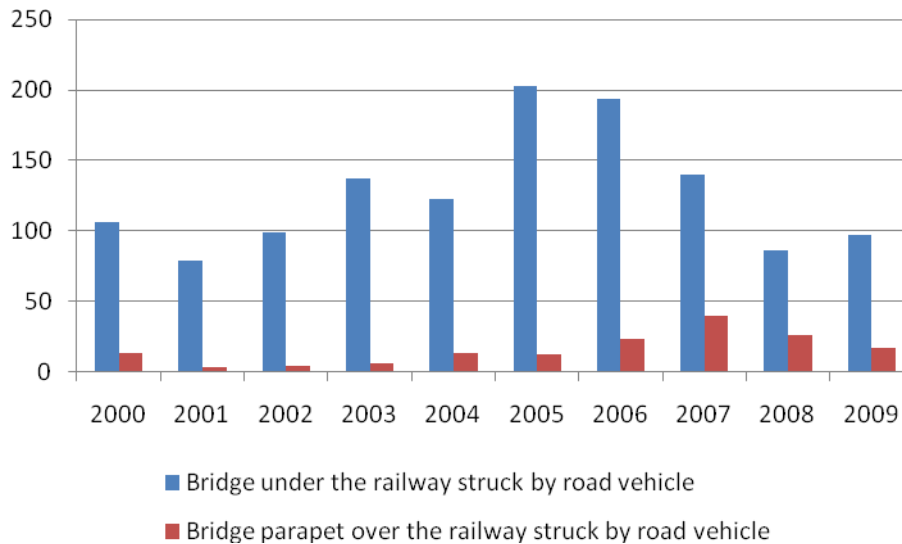
Graph 10: Railway Bridges struck by road vehicles

The total number of bridge strikes, i.e., under-bridge and over-bridge, in 2009 was the same as that for 2008. These figures represent a significant fall from the highs of 2005 and 2006 nonetheless the numbers remain high. IÉ categorise each strike depending on the severity and the breakdown for 2009 is illustrated in table 2.

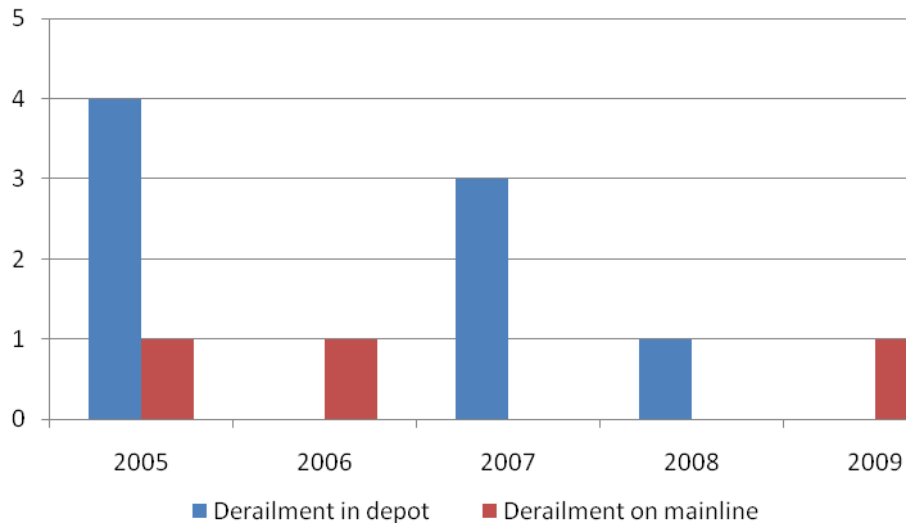
Graph 13: Tram Derailments

In 2009 one tram derailed while in passenger service. This occurred while a tram was traversing a set of points at a very low speed (approximately 15 kph) departing Connolly stop. It was caused by an item of clothing that had become wedged in the points. There were no injuries.

Since 2005, there have been a total of 11 tram derailments, eight in Luas depots and the remaining three occurring in passenger service. The three in service derailments all occurred at low speeds while a tram was traversing over points and crossings. Given there has been 13.351 million total tram-kilometres run, between January 2005 and the end of 2009, this represents one in-service tram derailment every 4.45 million tram-kilometres.
